**Inspection Date:** 2026-10-08  
**Inspector:** 6352  
**Inspection Type:** nmac  
**Odometer:** 25809 Miles

by Cox Automotive **Vehicle Report Condition**

**VIN:** 1N4BL4EWXPN425751  
**Make, Model, & Year:** Nissan Altima 2023  
**Trim:** 2.5 SL AWD Sedan  
**Exterior/Interior Color:** QAB - Pearl White Tricoat / G - Charcoal  
**Odometer:** 25809 Miles

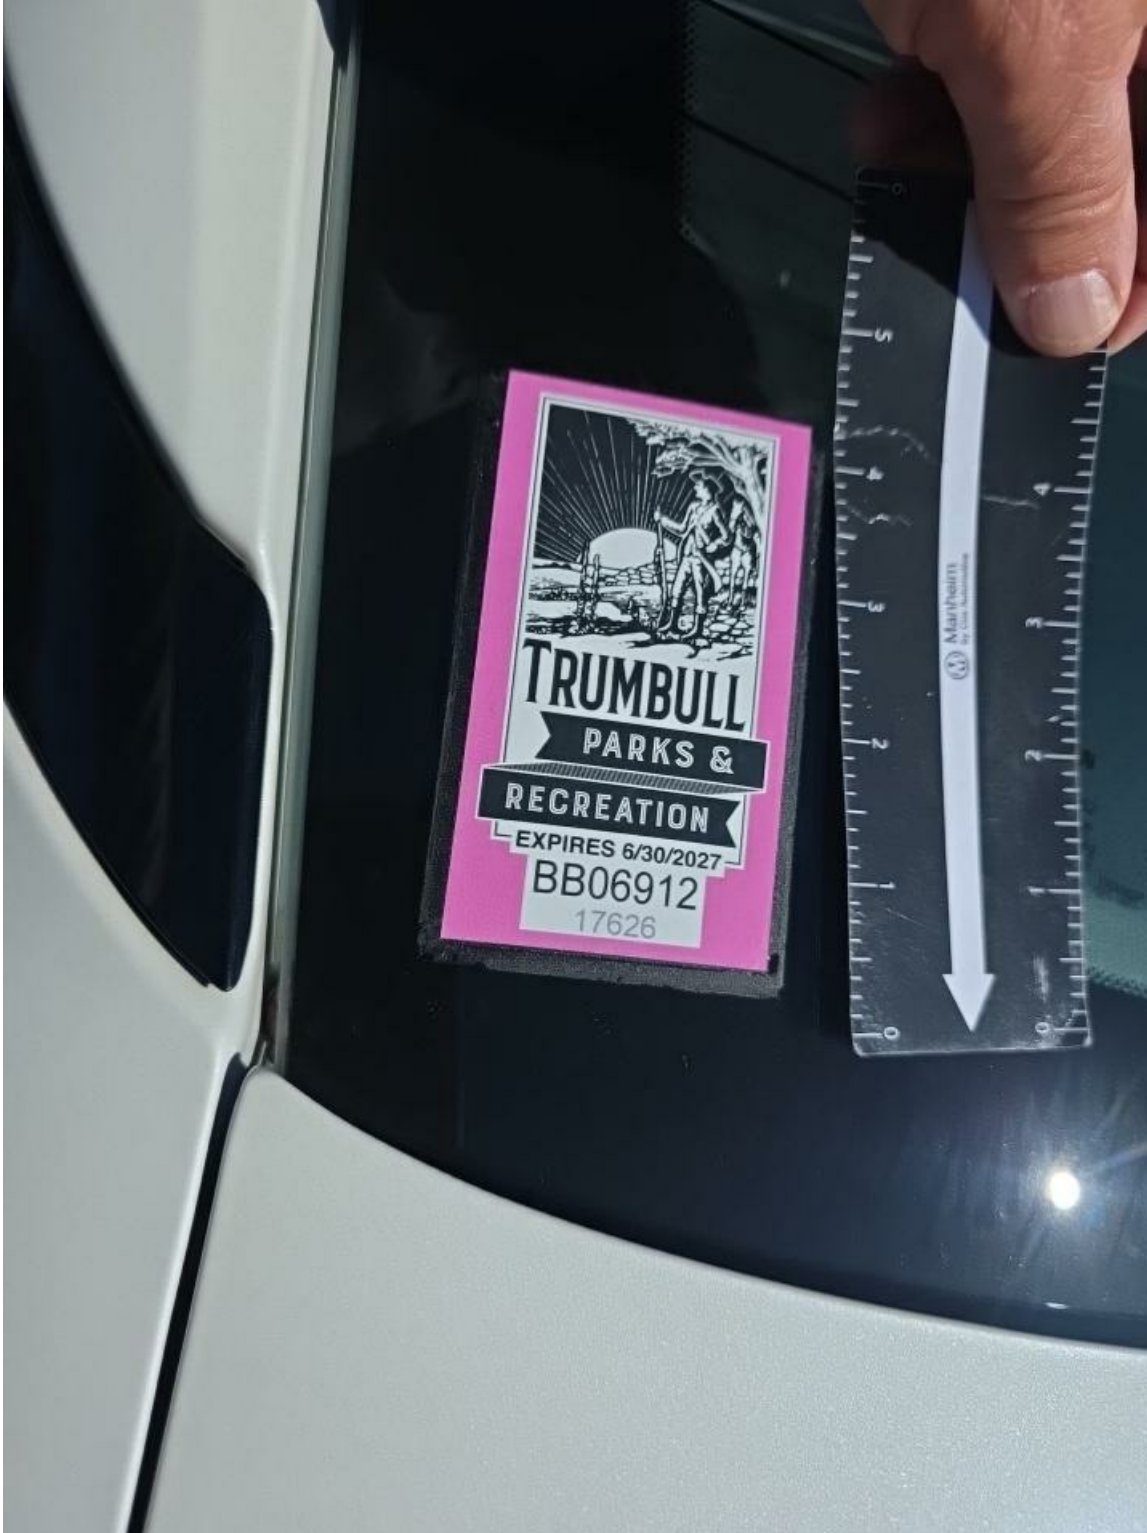
Rear Glass De-Identify Removal Required

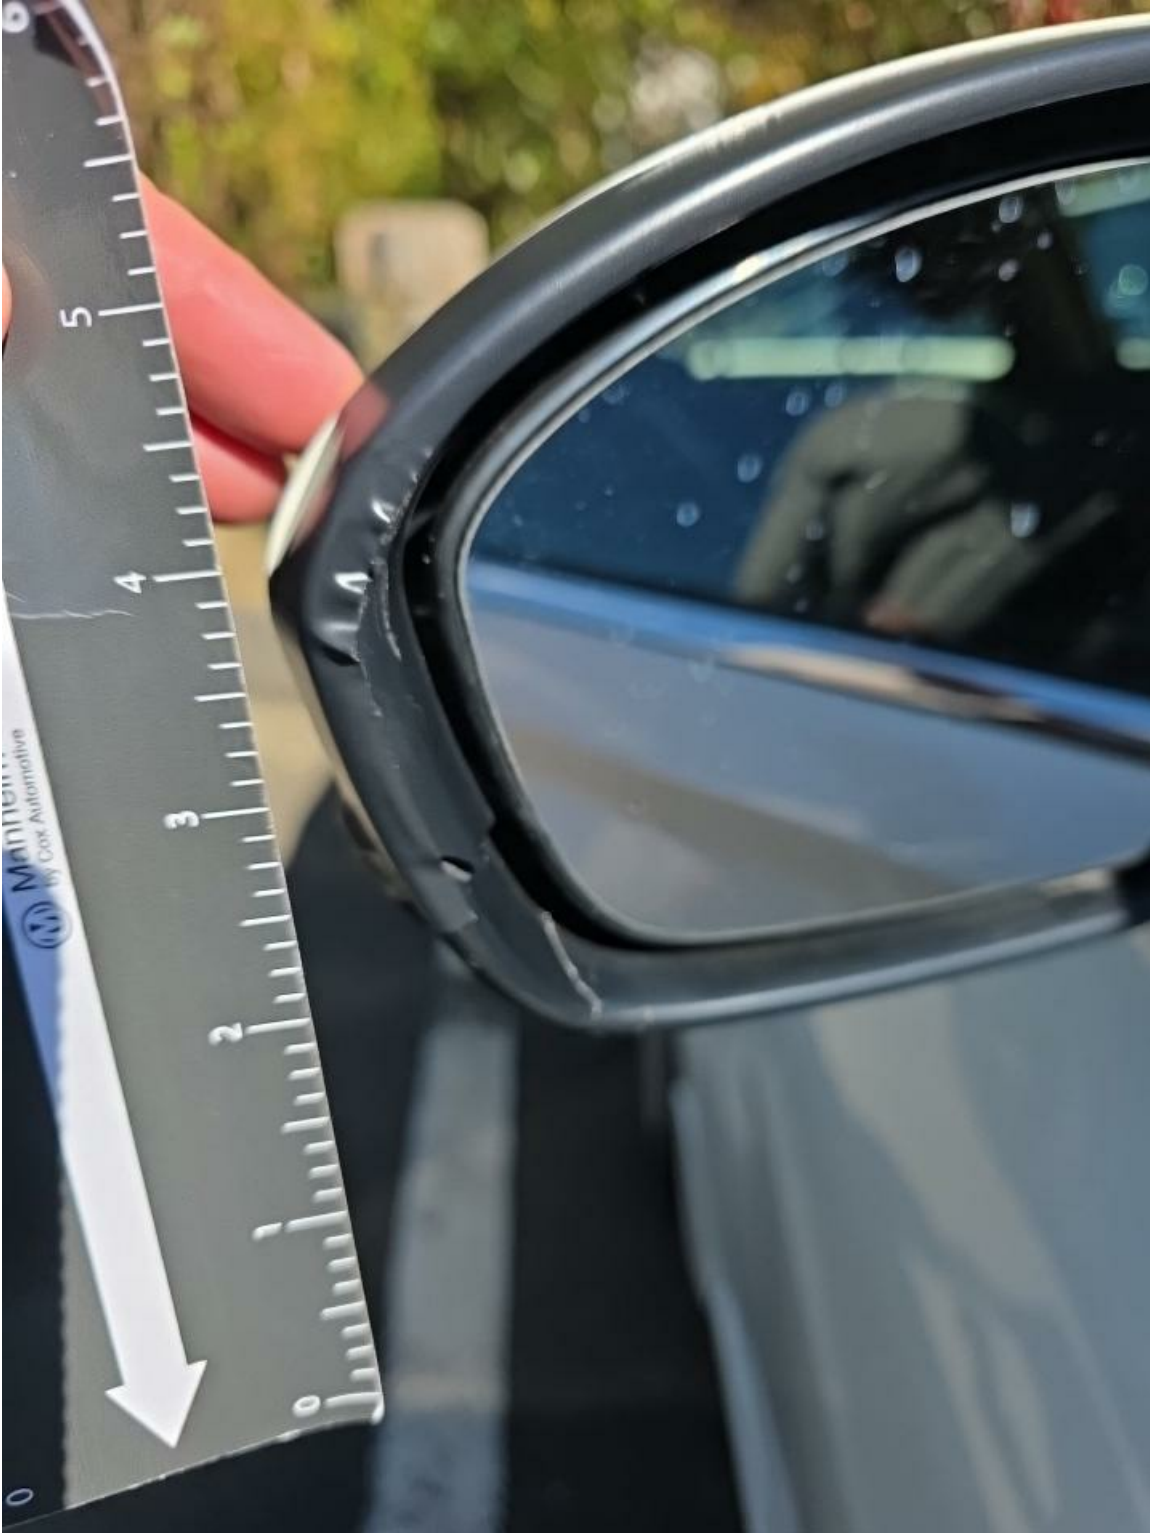
| Part Description | Damage Type | Severity | Labor Operation | Labor Total | Paint Total | Part Cost | Total |
|---|---|---|---|---|---|---|---|
| LF Mirror Housing | Cracked | 2" to 3" | Replace | 12.00 | --- | 343.27 | 355.27 |

LF Mirror Housing Cracked 2" to 3"

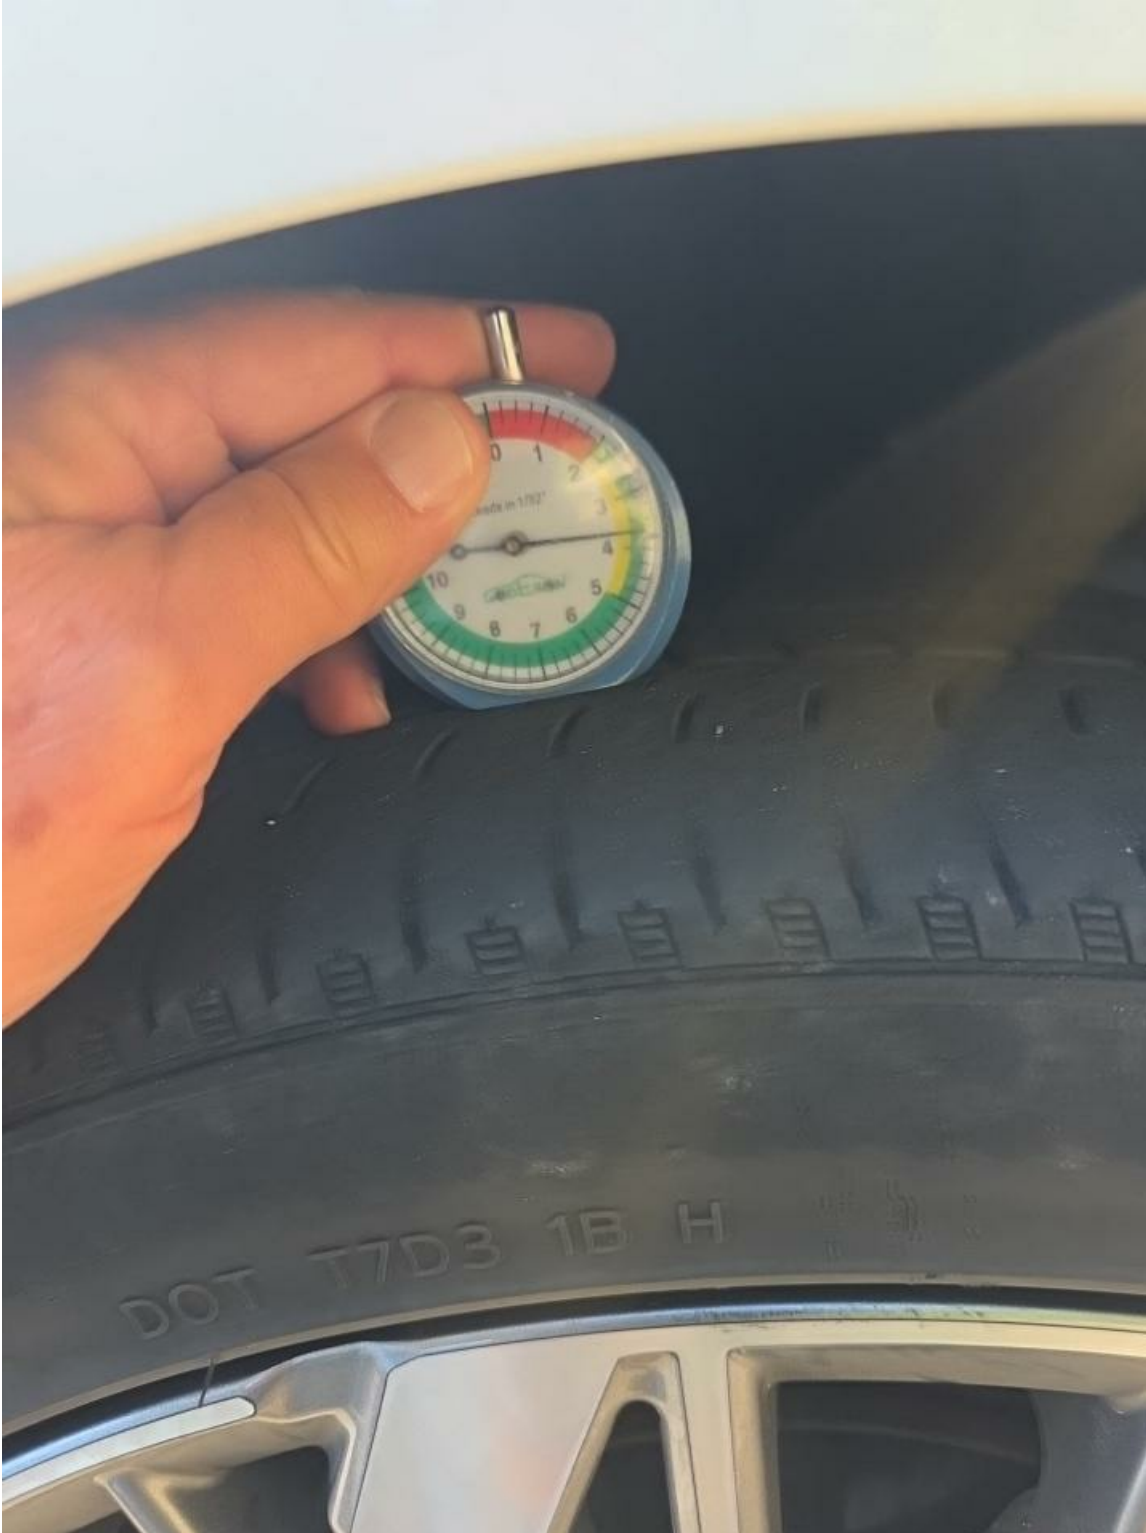
| Part | Tread Depth | Manufacturer | Size |
|---|---|---|---|
| RIGHT-FRONT | 3/32 | HANKOOK | 235-40-19 |

| Part Description | Damage Type | Severity | Labor Operation | Labor Total | Paint Total | Part Cost | Total |
|---|---|---|---|---|---|---|---|
| RF Tire | Worn | Replacement Required | Replace | 0.00 | --- | 175.00 | 175.00 |

RF Tire Worn Replacement Required
