OVERVIEW

| Make, Model, & Year: | Nissan Rogue 2023 | Inspector: | 9829 |

by Cox Automotive **Vehicle Report Condition**

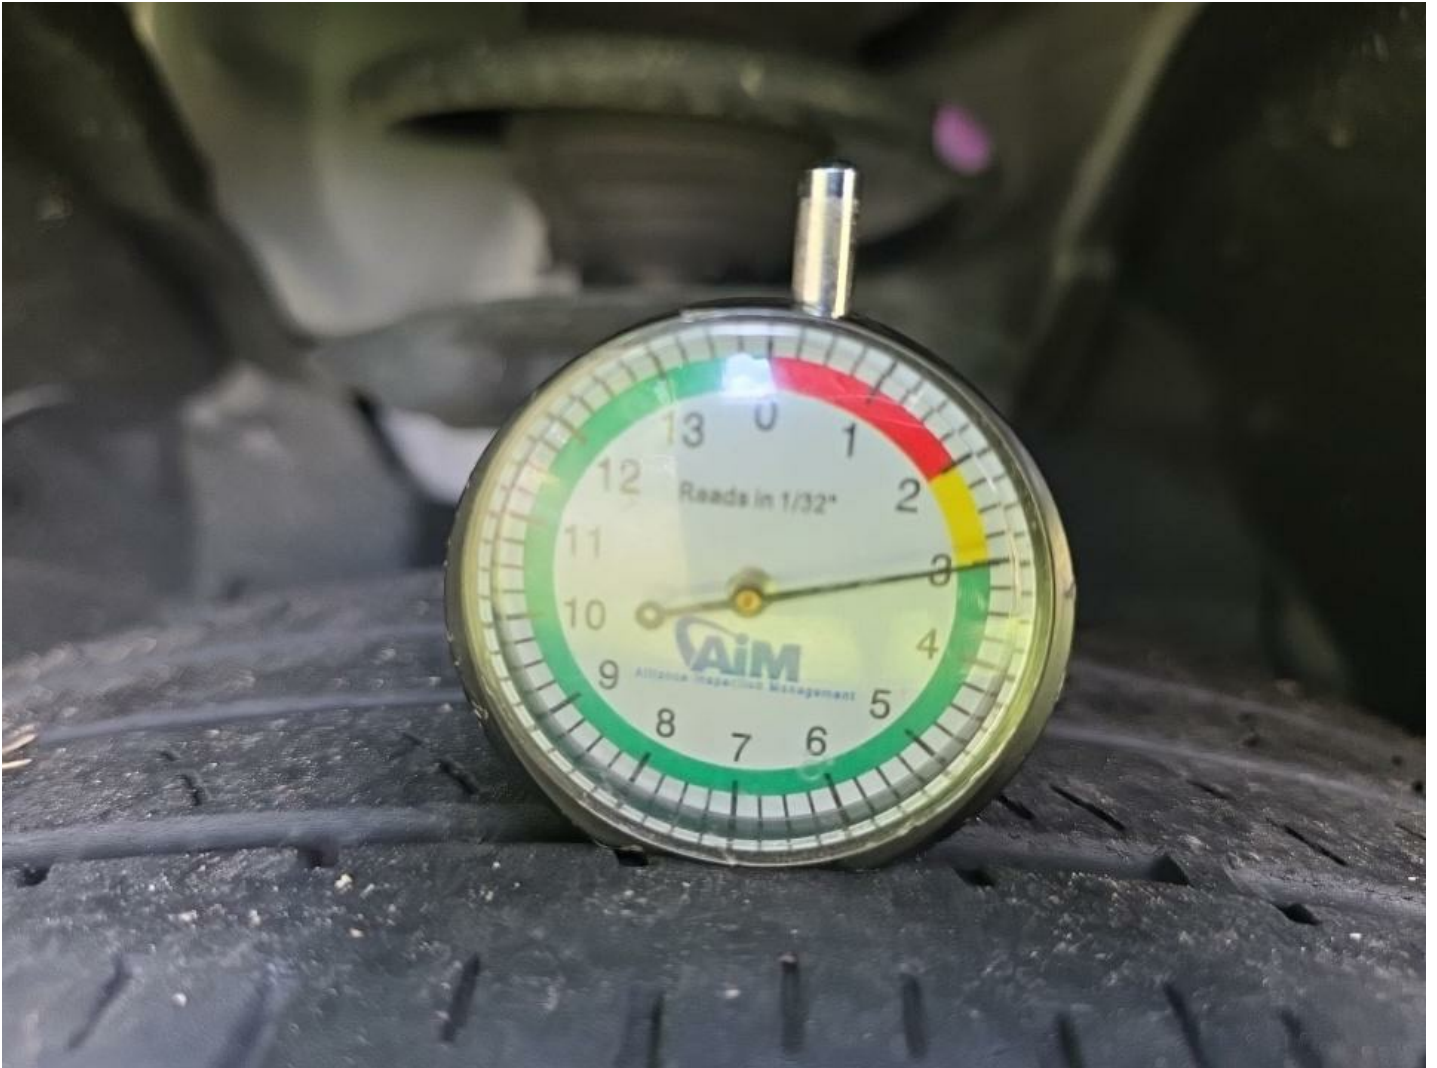
RF Tire Worn Replacement Required

| Part Description | Damage Type | Severity | Labor Operation | Labor Total | Paint Total | Part Cost | Total |
|---|---|---|---|---|---|---|---|
| RF Tire | Worn | Replacement Required | Replace | 0.00 | --- | 150.00 | 150.00 |

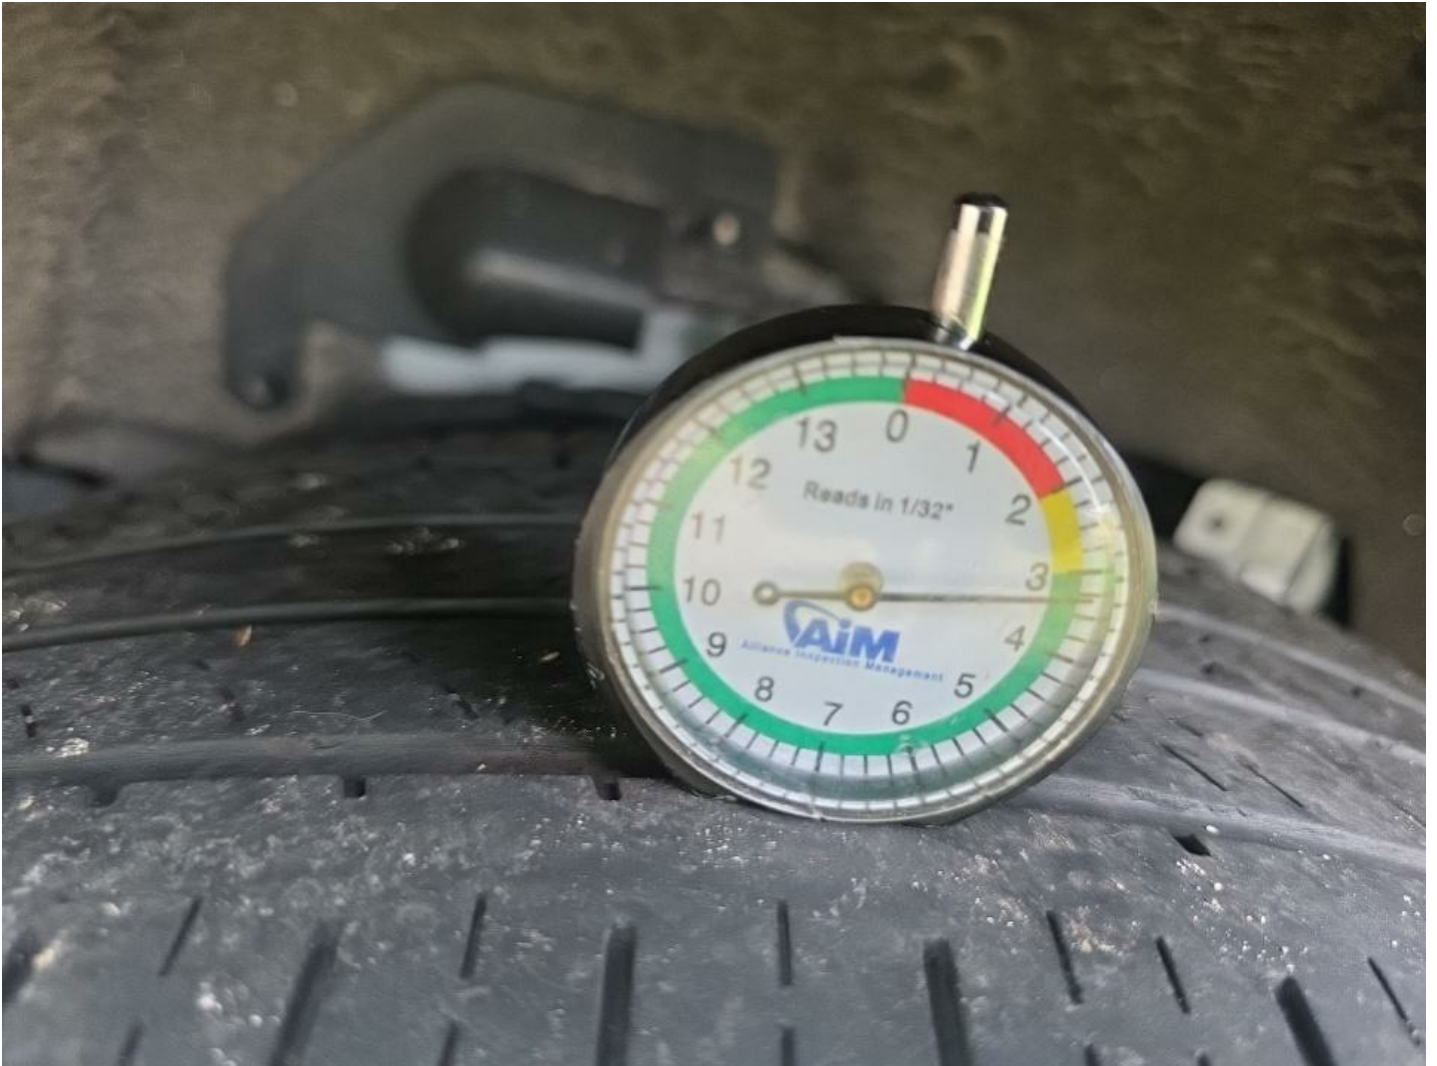
RR Tire Worn Replacement Required

| Part Description | Damage Type | Severity | Labor Operation | Labor Total | Paint Total | Part Cost | Total |
|---|---|---|---|---|---|---|---|
| RR Tire | Worn | Replacement Required | Replace | 0.00 | --- | 150.00 | 150.00 |

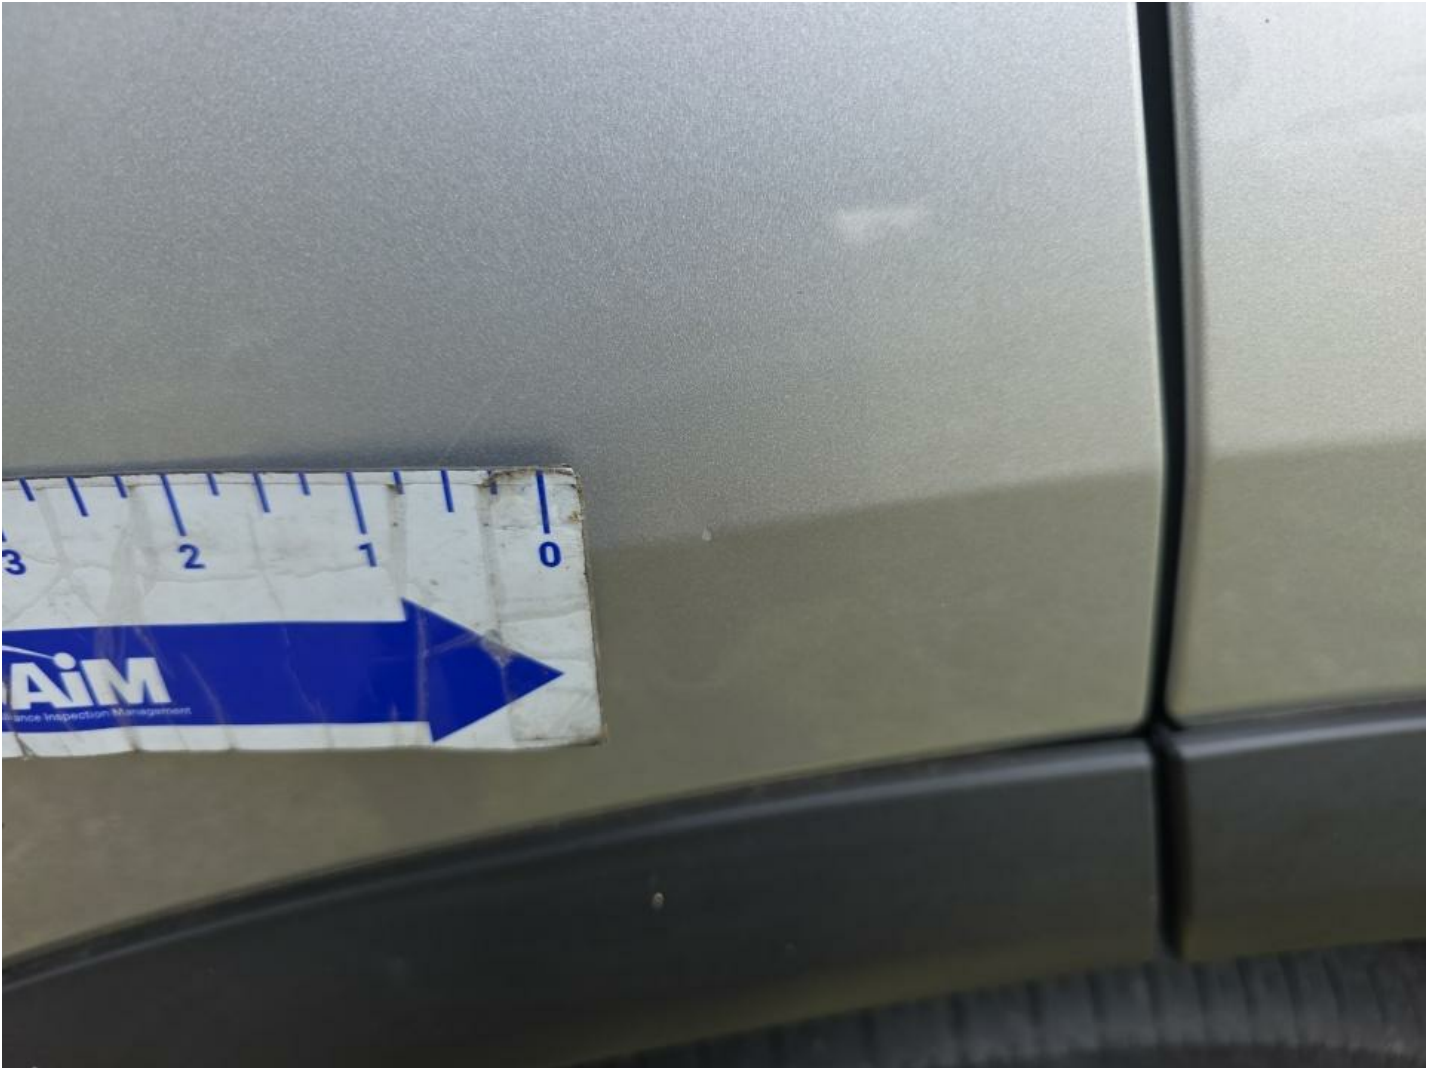
R Qtr Panel Dent/No Paint Dmg 1/8" to 1/2"

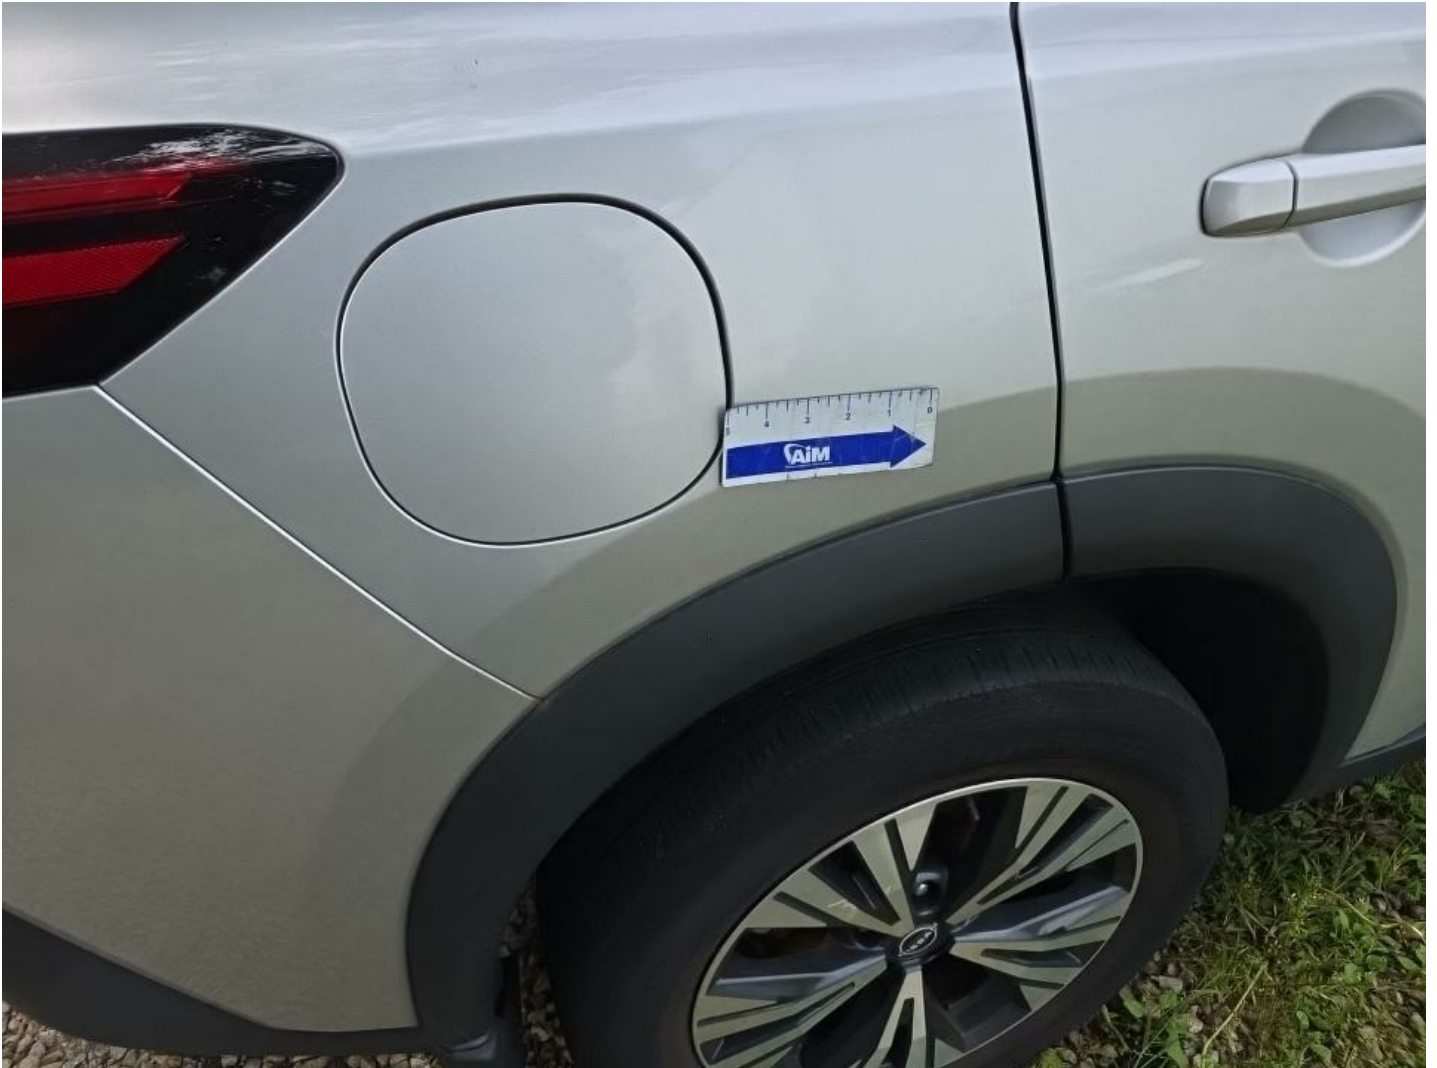
R Qtr Panel Dent/No Paint Dmg 1/8" to 1/2"

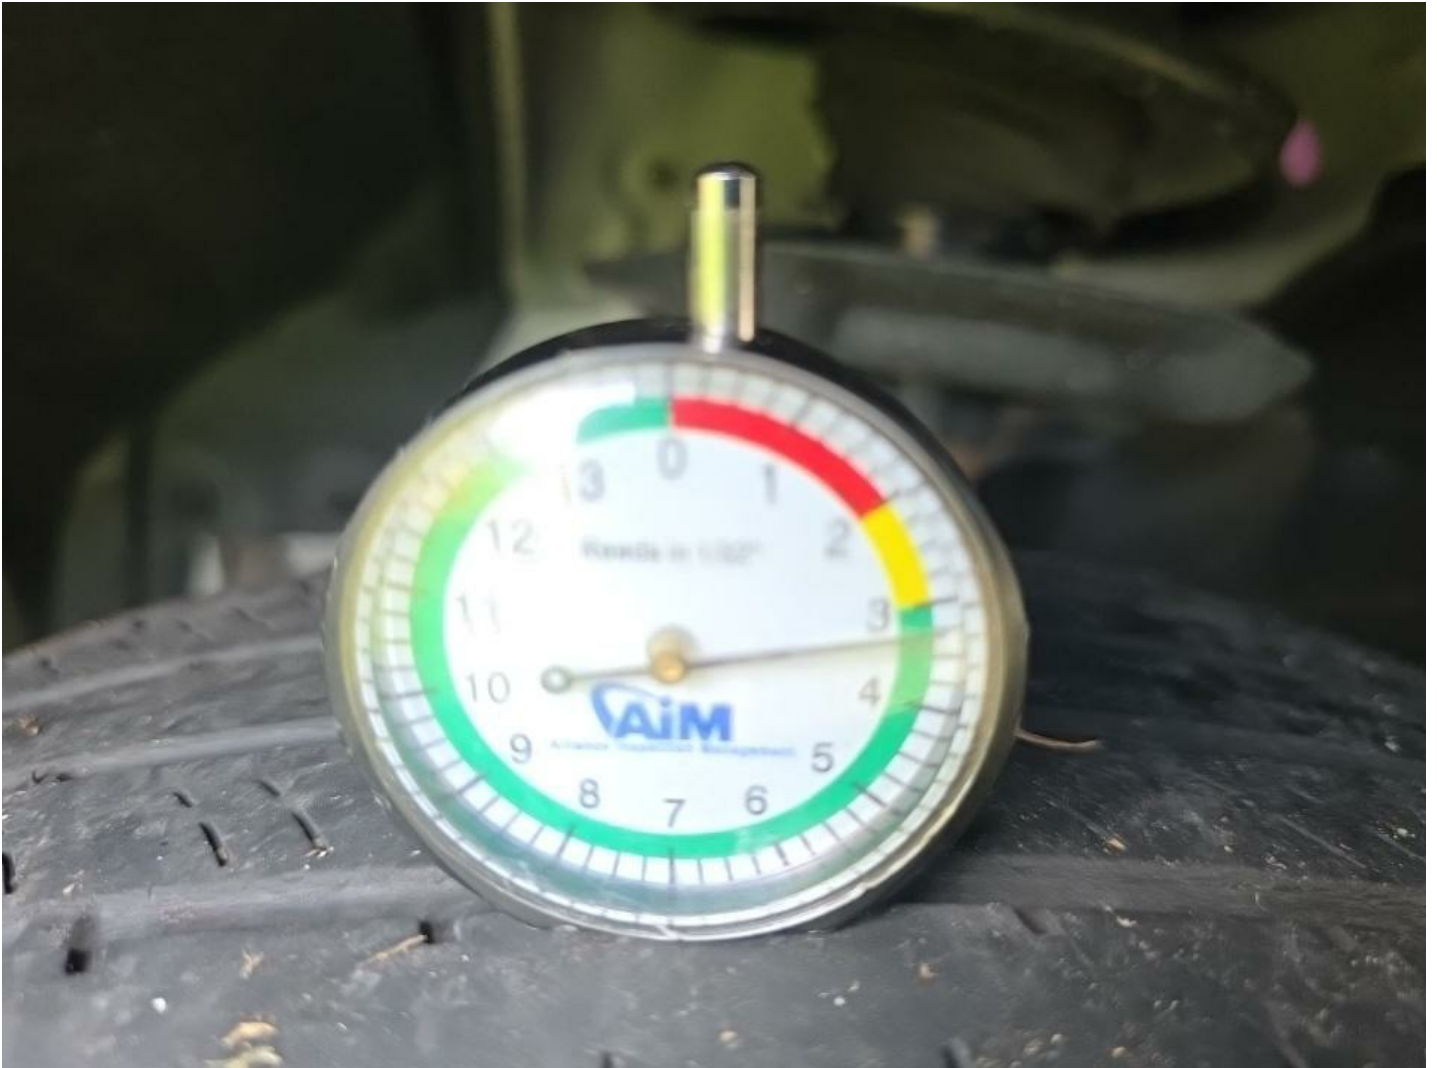
LF Tire Worn Replacement Required

| Part Description | Damage Type | Severity | Labor Operation | Labor Total | Paint Total | Part Cost | Total |
|---|---|---|---|---|---|---|---|
| LF Tire | Worn | Replacement Required | Replace | 0.00 | --- | 150.00 | 150.00 |
