| <b>VIN:</b> | 5N1BT3BB6PC859548 |
| <b>Make, Model, &amp; Year:</b> | Nissan Rogue 2023 |

| <b>Inspection Date:</b> | 2026-09-16 |

Vehicle Report Condition

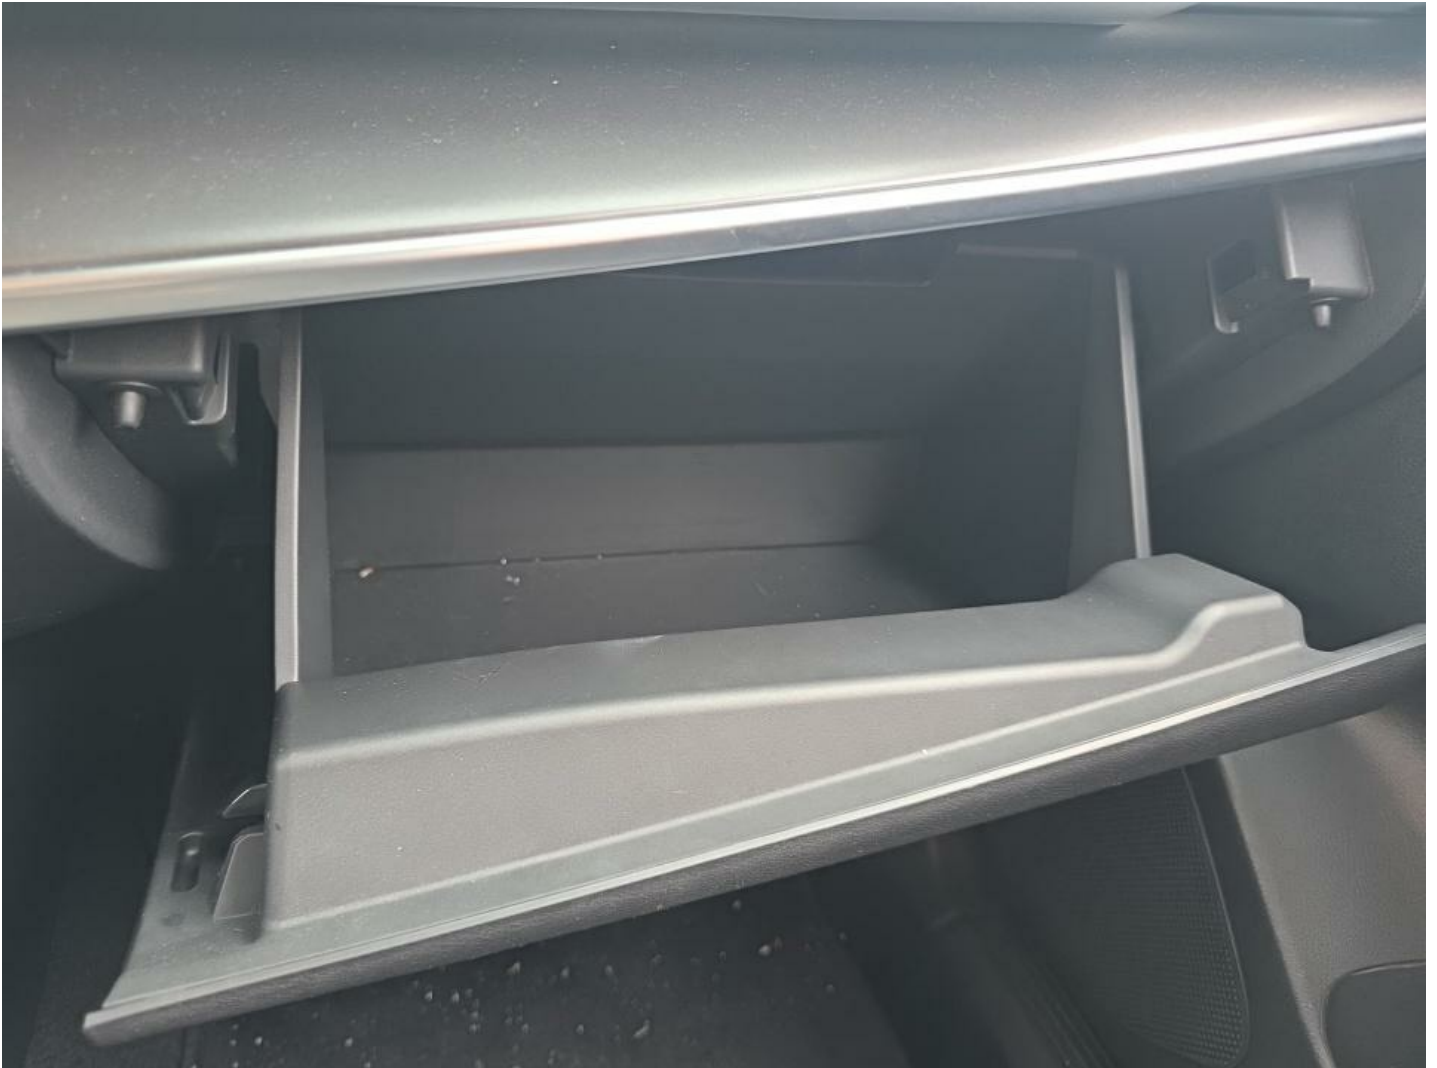
Owners manuals Missing Replacement Required

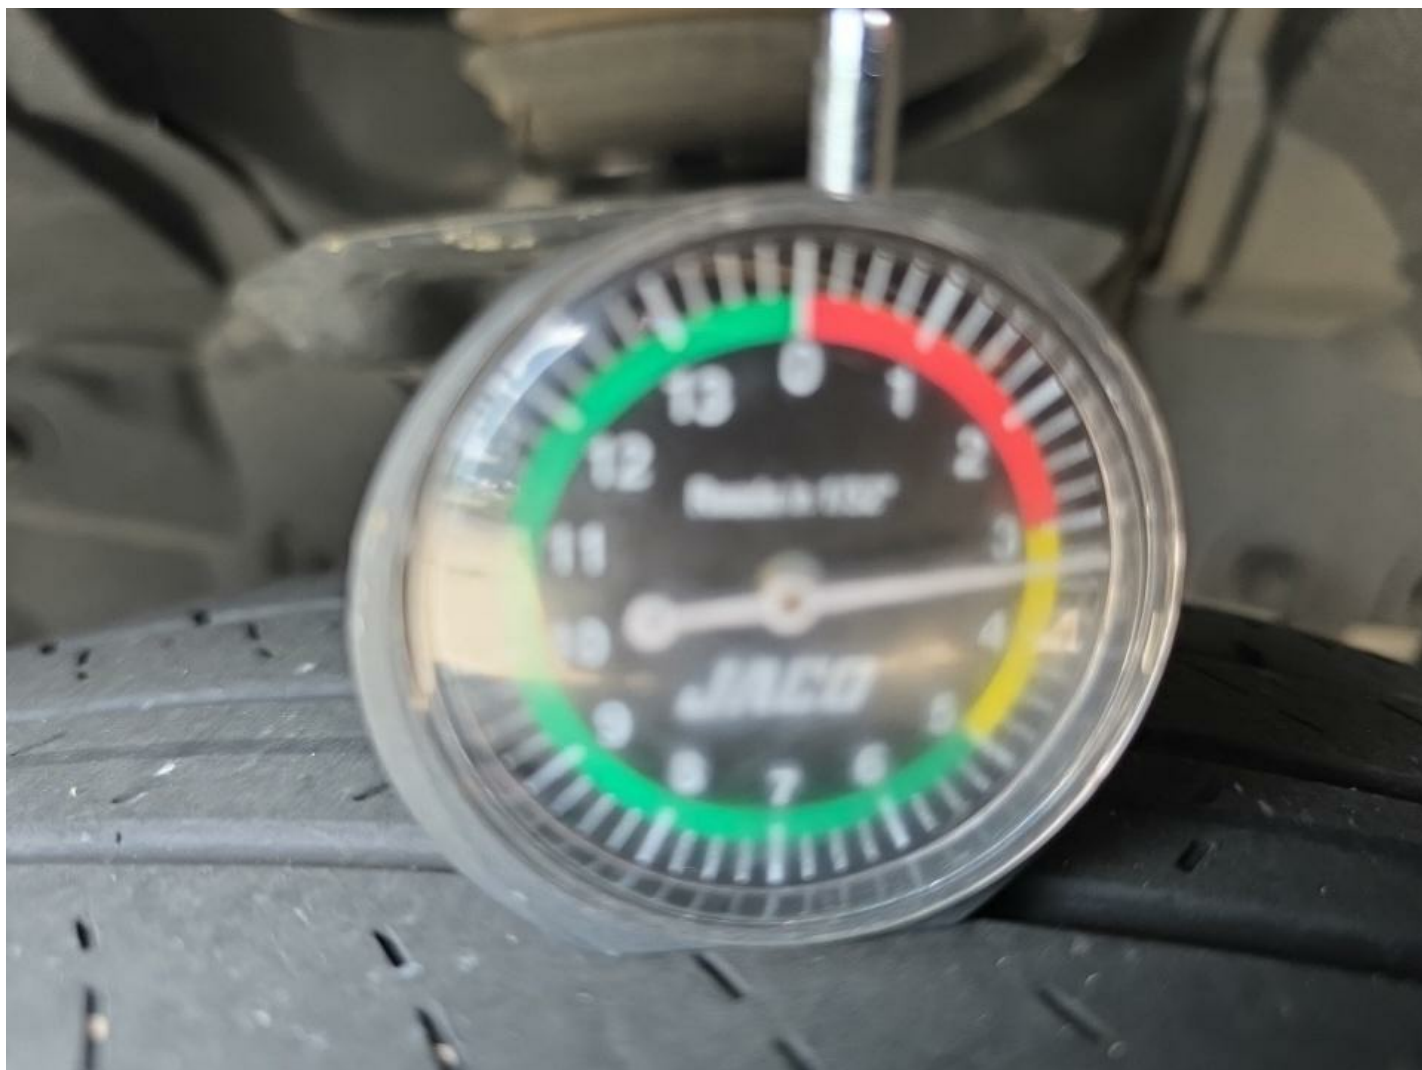
| Part | Tread Depth | Manufacturer | Size |
|---|---|---|---|
| RIGHT-FRONT | 3/32 | HANKOOK | 235-60-18 |

RF Tire Worn Replacement Required

| Part Description | Damage Type | Severity | Labor Operation | Labor Total | Paint Total | Part Cost | Total |
|---|---|---|---|---|---|---|---|
| RF Tire | Worn | Replacement Required | Replace | 0.00 | --- | 150.00 | 150.00 |

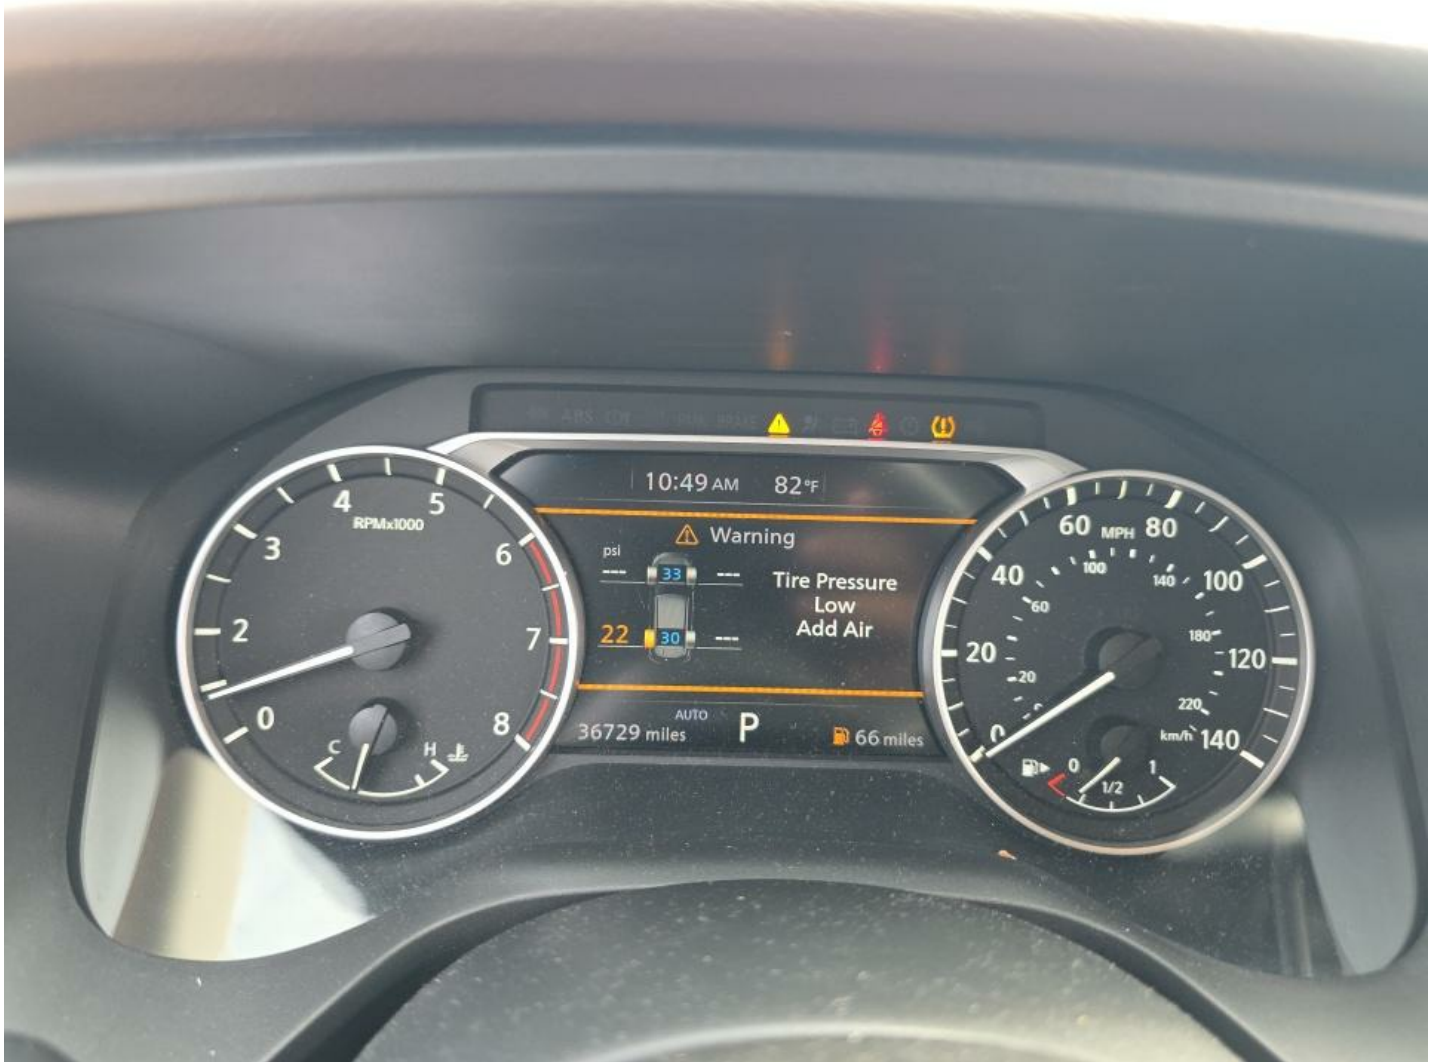
Warning - Tire Pressure On Unacceptable

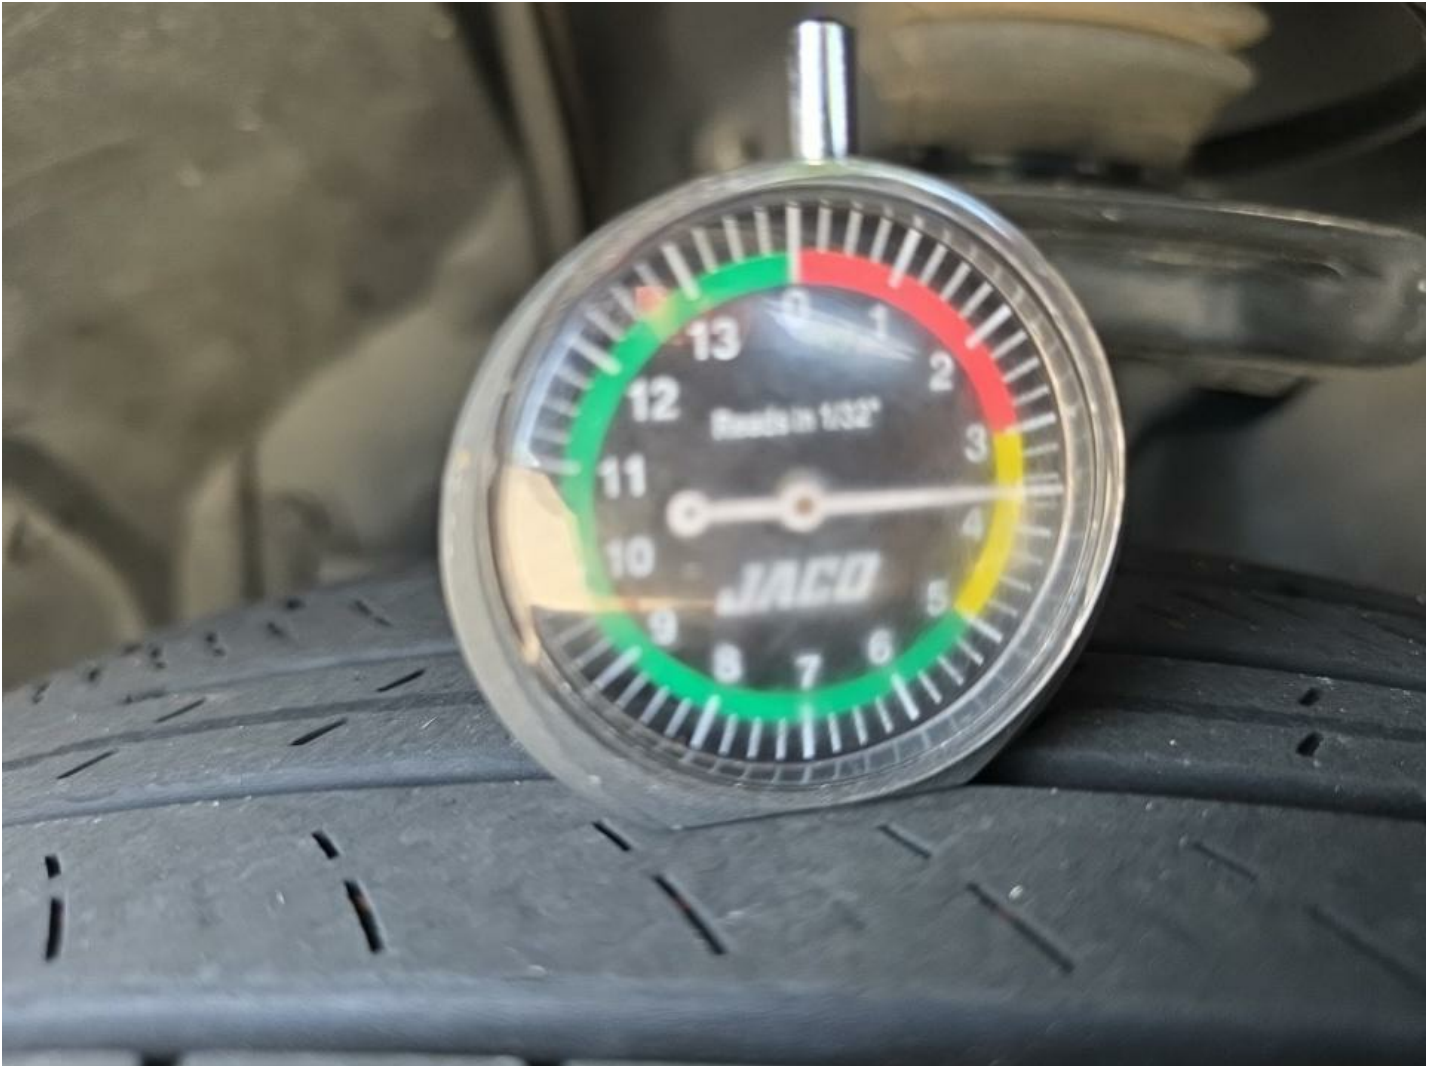
| Part | Tread Depth | Manufacturer | Size |
|---|---|---|---|
| LEFT-FRONT | 3/32 | HANKOOK | 235-60-18 |

LF Tire Worn Replacement Required

| Part Description | Damage Type | Severity | Labor Operation | Labor Total | Paint Total | Part Cost | Total |
|---|---|---|---|---|---|---|---|
| LF Tire | Worn | Replacement Required | Replace | 0.00 | --- | 150.00 | 150.00 |
