OVERVIEW

| Make, Model, & Year: | Nissan Rogue 2023 | Inspector: | 10046 |

by Cox Automotive **Vehicle Report Condition**

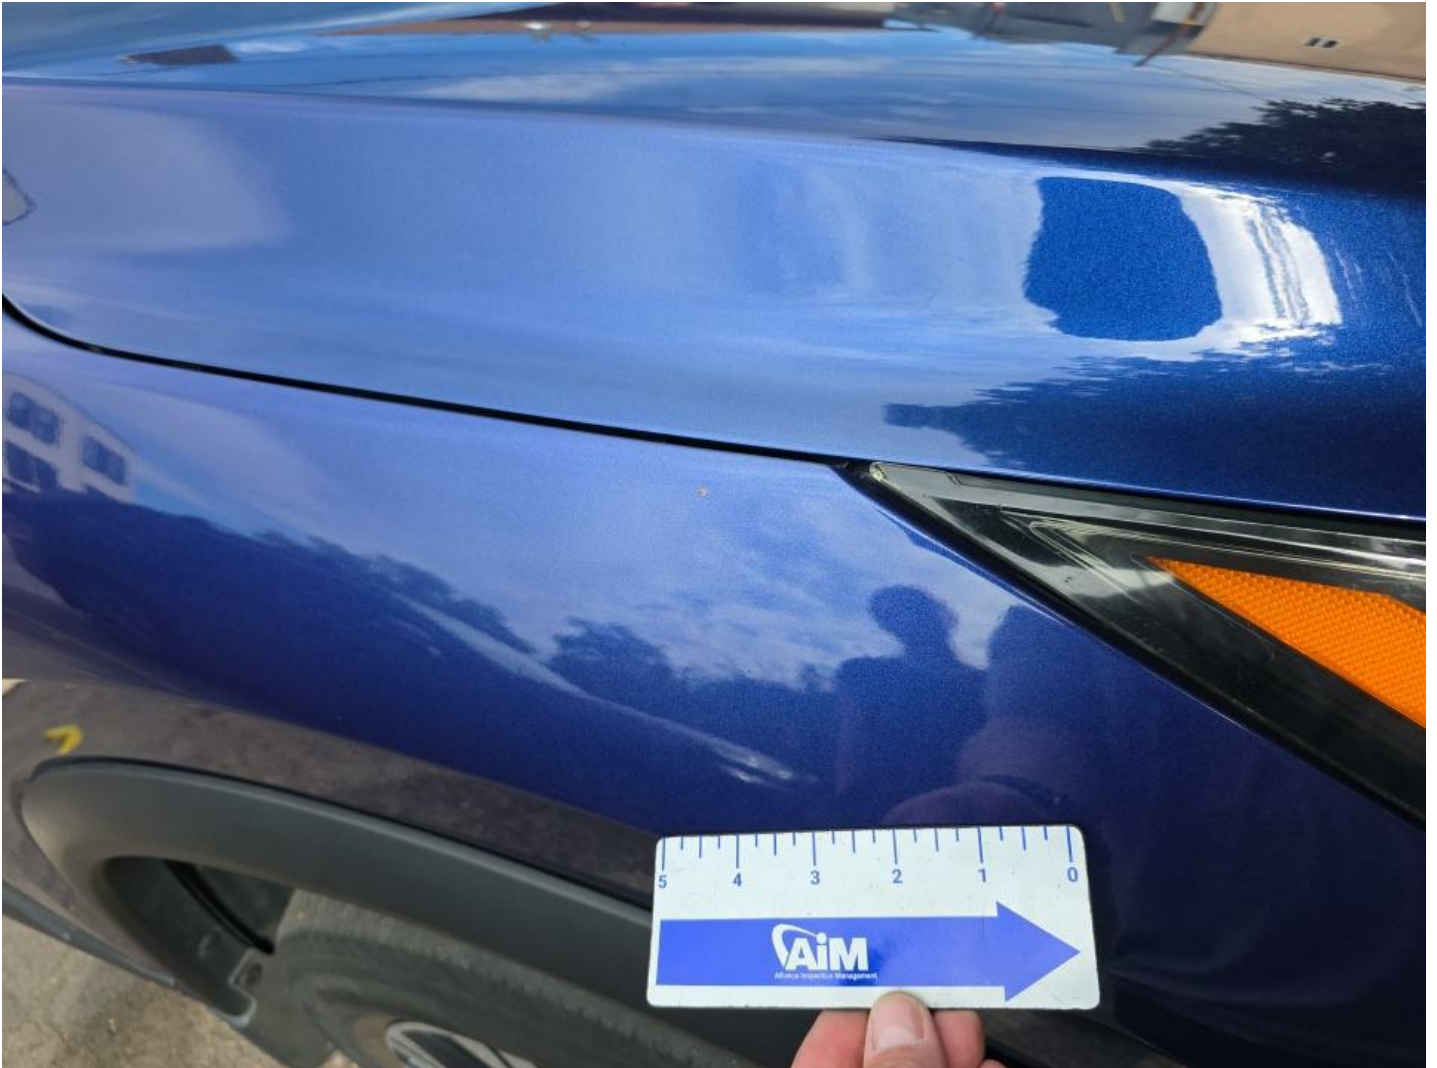
RF Fender Prev Repair Acceptable

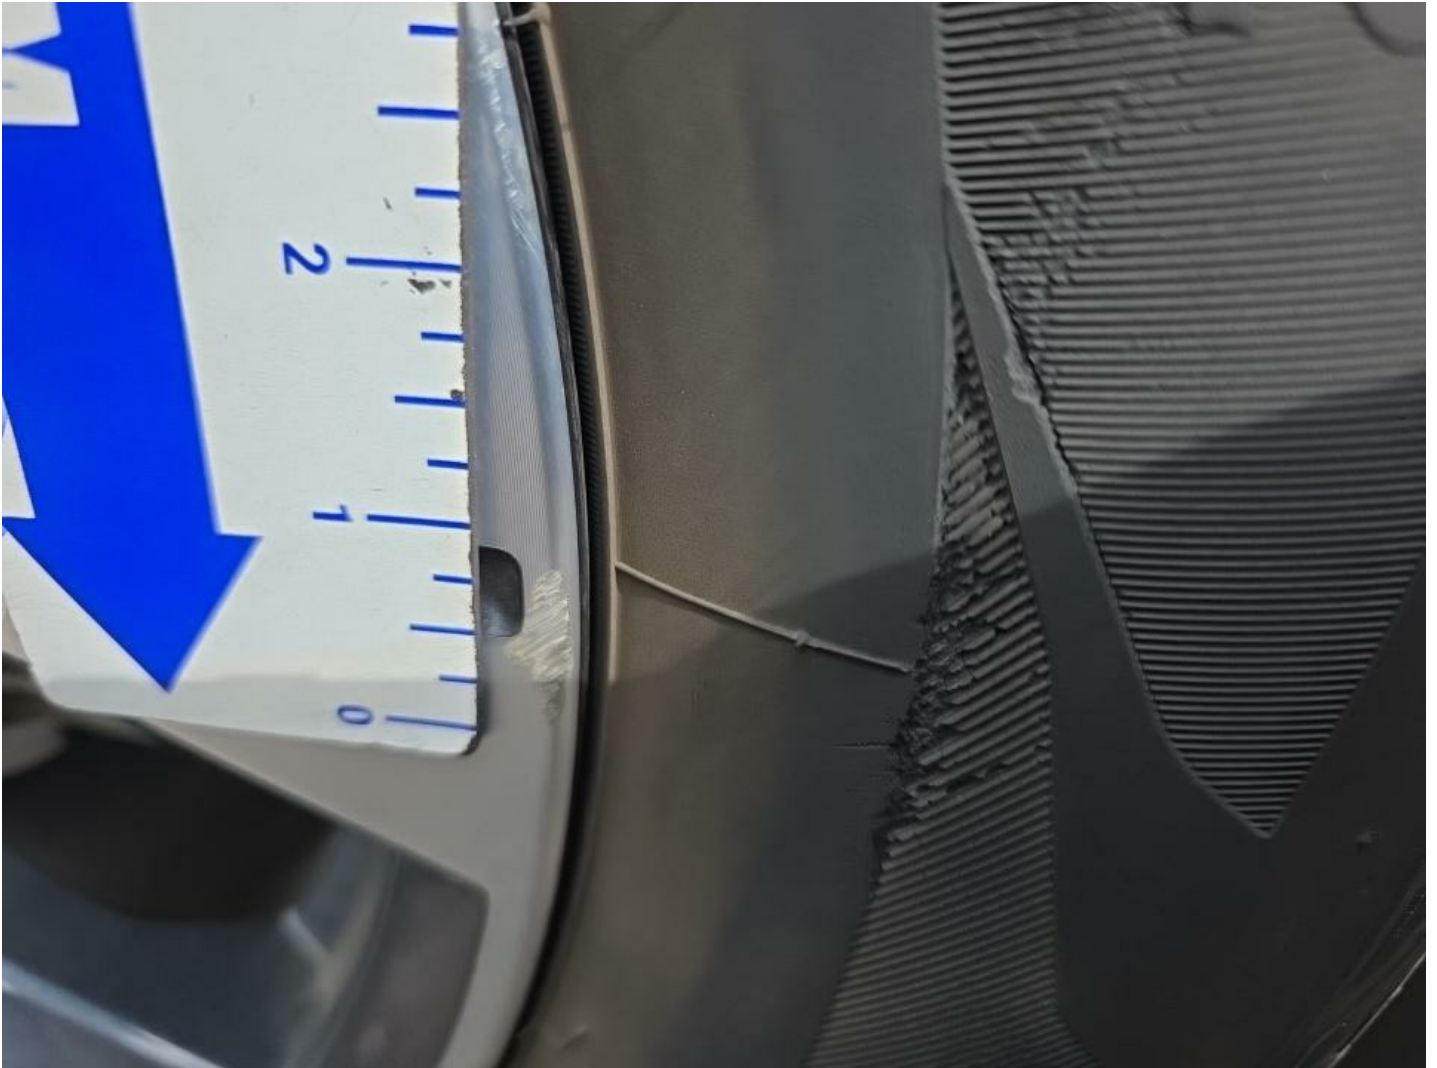
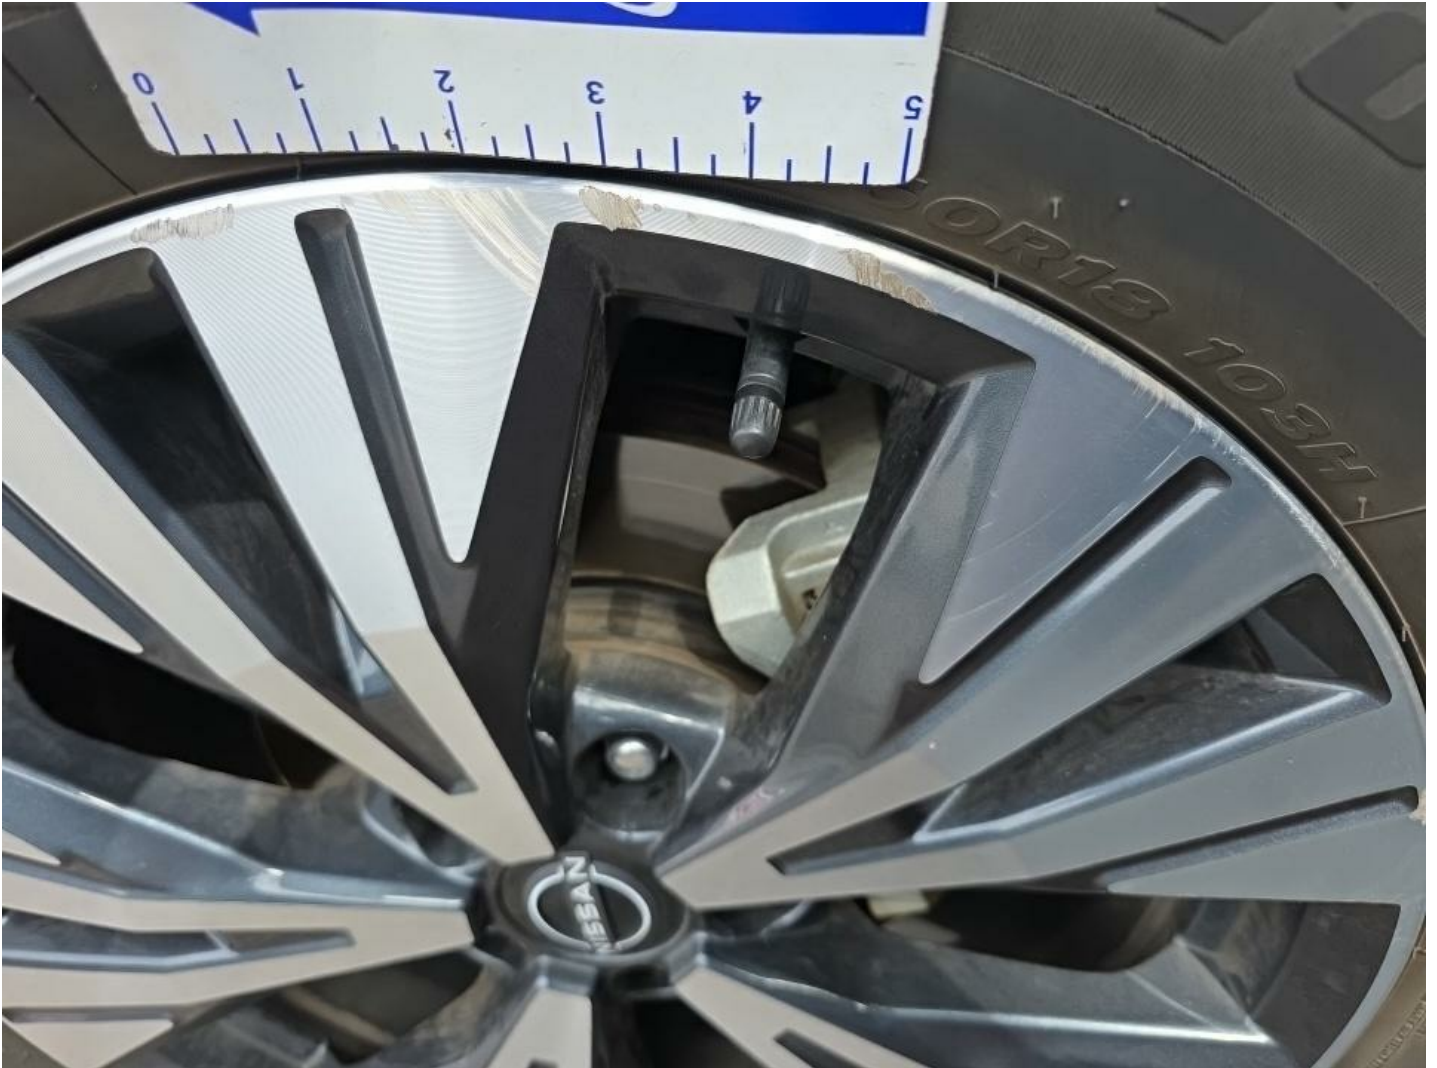
| Part Description | Damage Type | Severity | Labor Operation | Labor Total | Paint Total | Part Cost | Total |
|---|---|---|---|---|---|---|---|
| RF Wheel | Curb Rash | 7" to 8" | Flat Fee | 0.00 | --- | 0.00 | 55.00 |

RF Wheel Curb Rash 7" to 8"

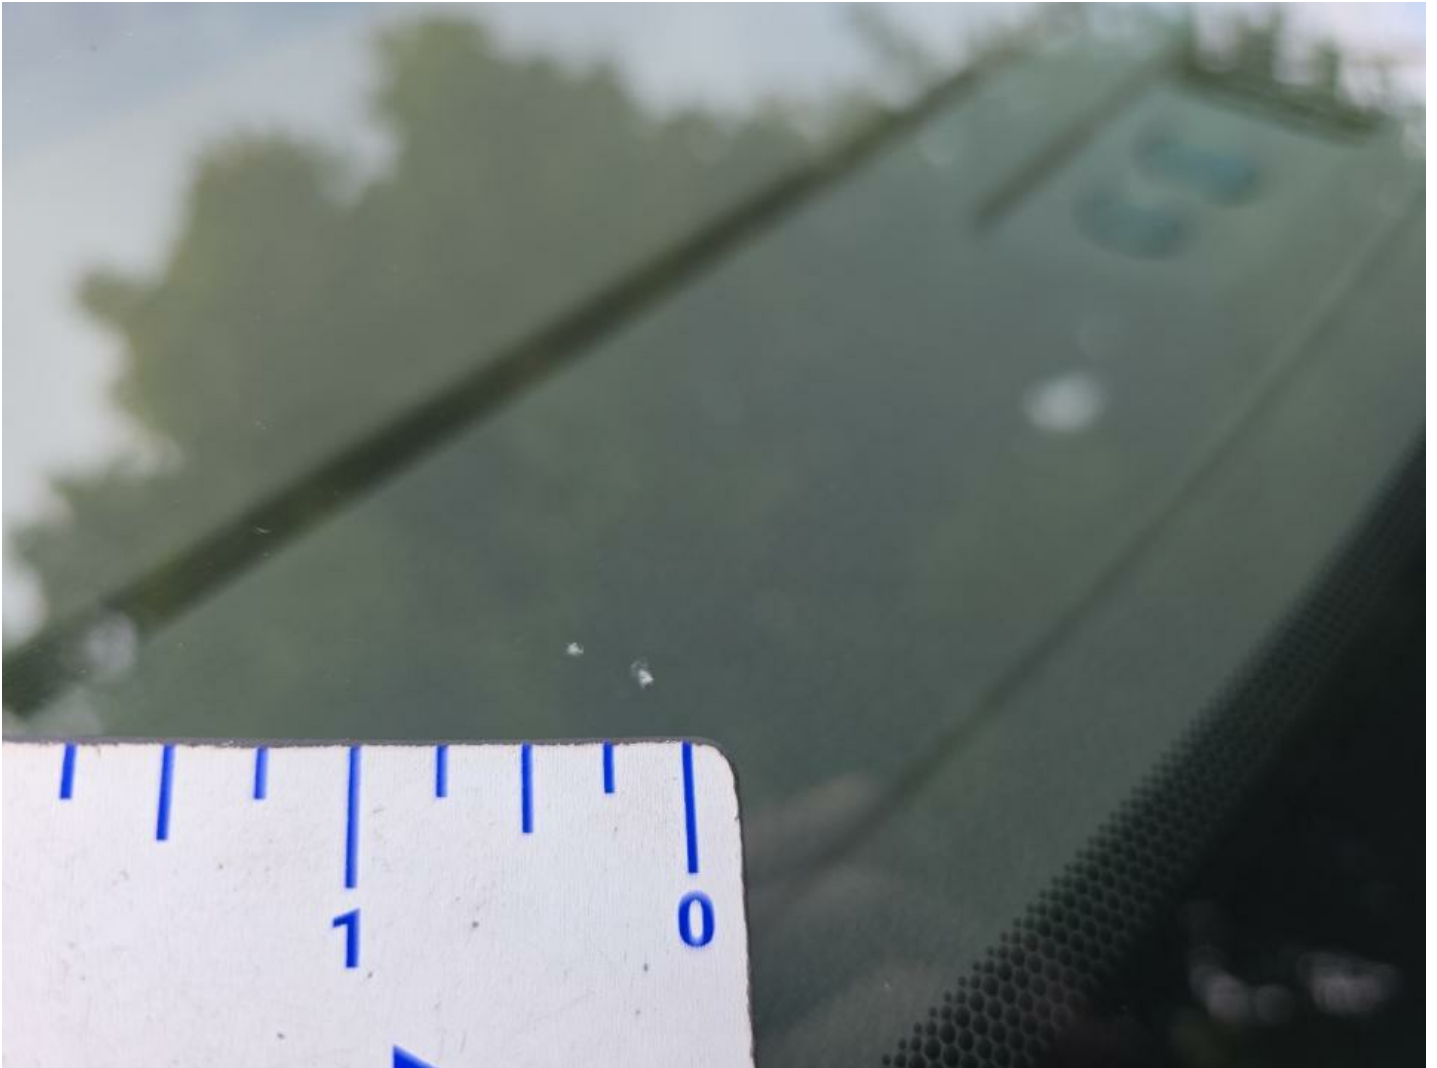
Windshield Chipped < 1/8"

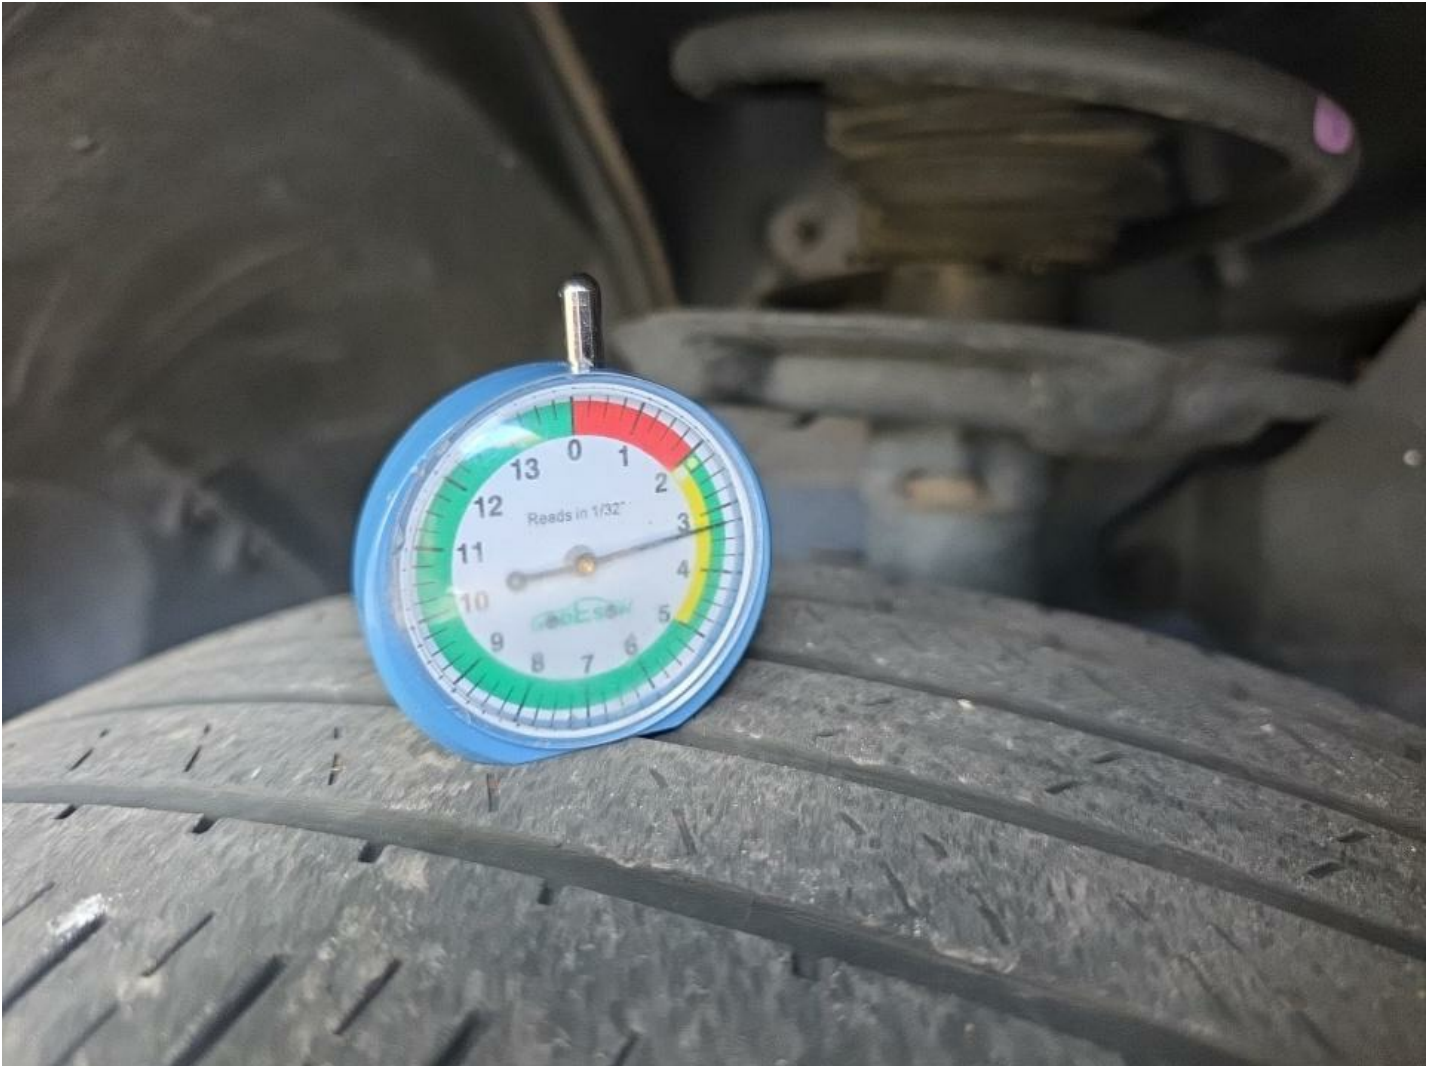
| Part | Tread Depth | Manufacturer | Size |
|---|---|---|---|
| LEFT-FRONT | 3/32 | HANKOOK | 235-60-18 |

LF Tire Worn Replacement Required

| Part Description | Damage Type | Severity | Labor Operation | Labor Total | Paint Total | Part Cost | Total |
|---|---|---|---|---|---|---|---|
| LF Tire | Worn | Replacement Required | Replace | 0.00 | --- | 150.00 | 150.00 |

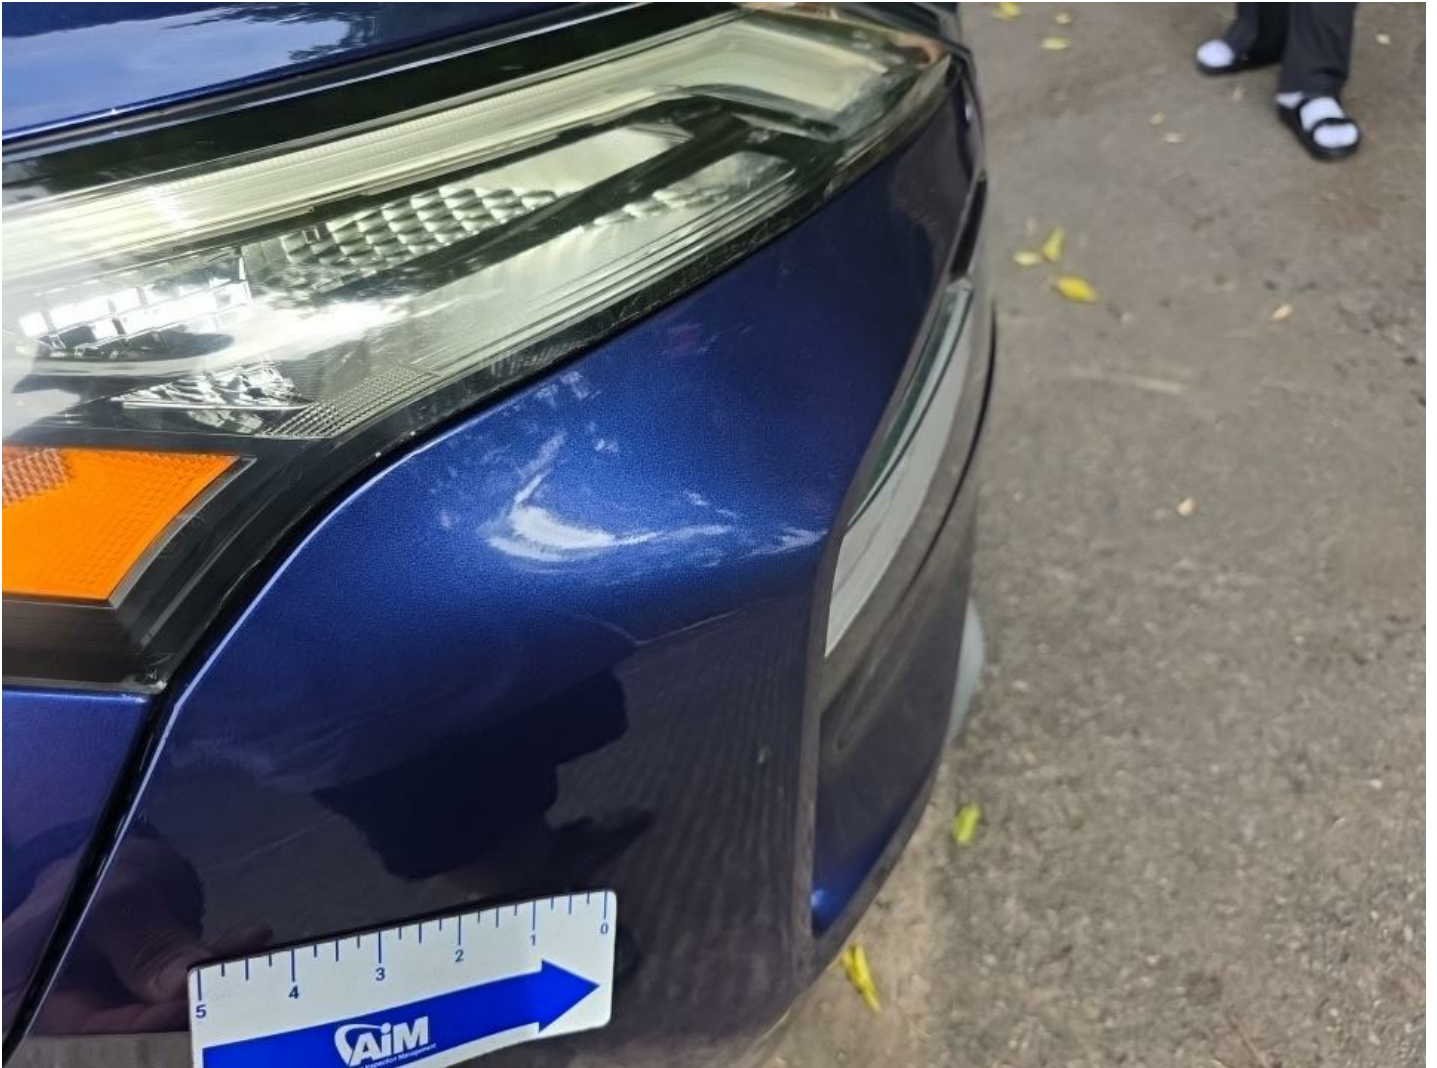
Front Bumper Prev Repair Acceptable

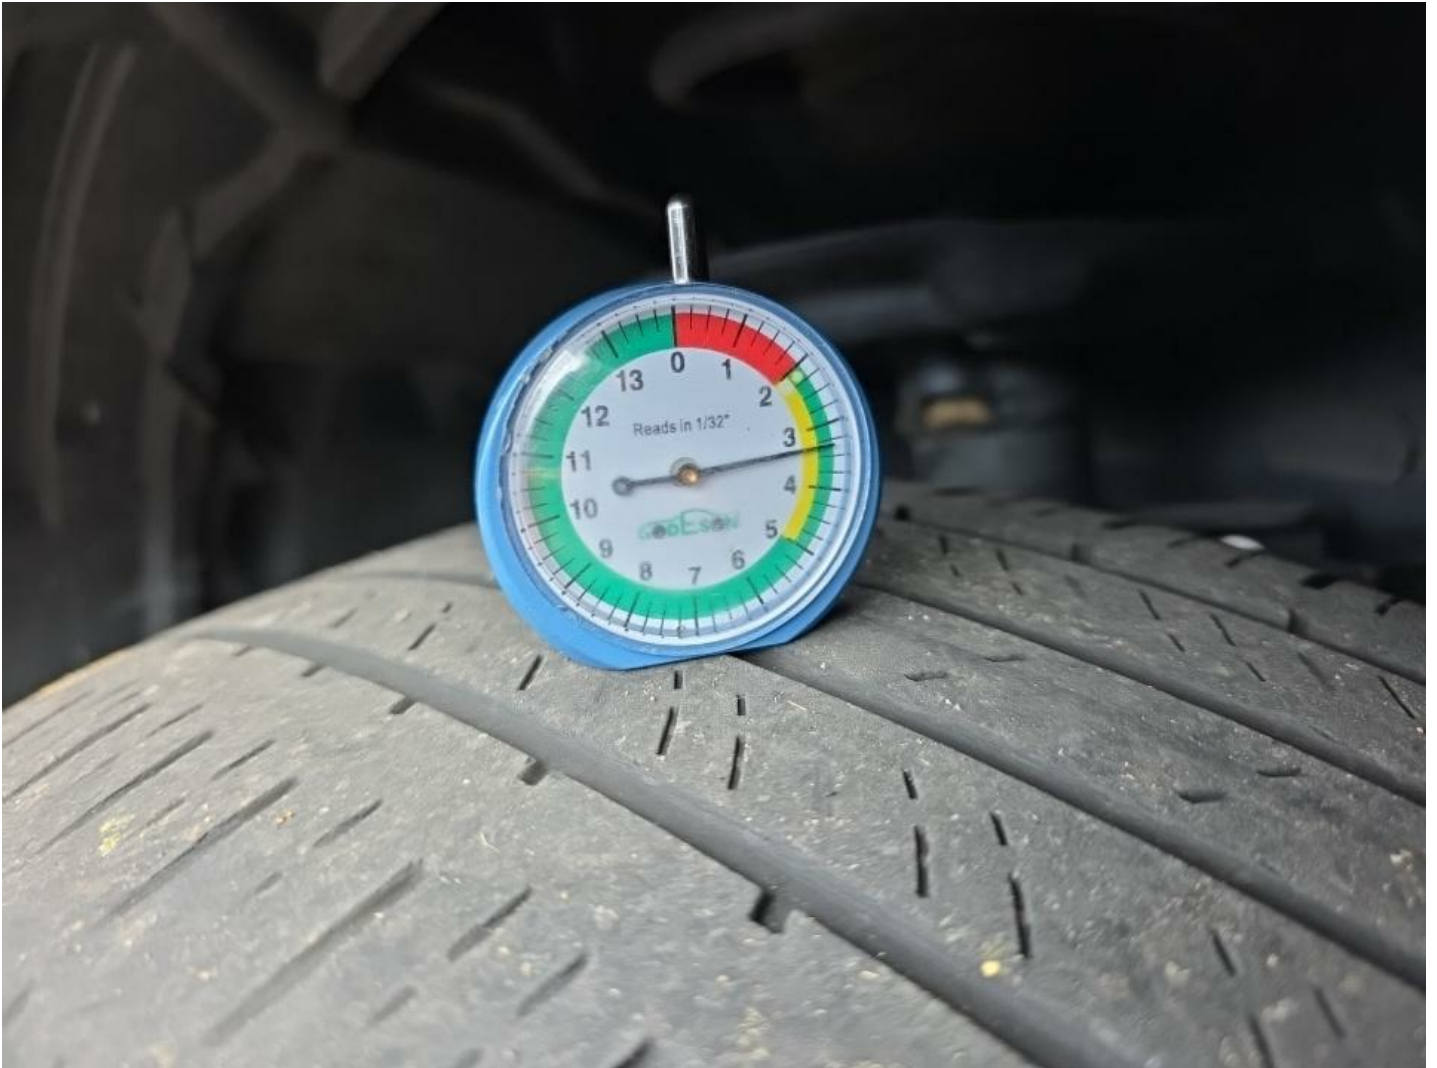
| Part | Tread Depth | Manufacturer | Size |
|---|---|---|---|
| RIGHT-FRONT | 3/32 | HANKOOK | 235-60-18 |

RF Tire Worn Replacement Required

| Part Description | Damage Type | Severity | Labor Operation | Labor Total | Paint Total | Part Cost | Total |
|---|---|---|---|---|---|---|---|
| RF Tire | Worn | Replacement Required | Replace | 0.00 | --- | 150.00 | 150.00 |
