OVERVIEW

| VIN: | JN8BT3BA7PW429297 | Inspection Date: | 2026-10-06 |
| Make, Model, & Year: | Nissan Rogue 2023 | Inspector: | 10148 |

Vehicle Report Condition

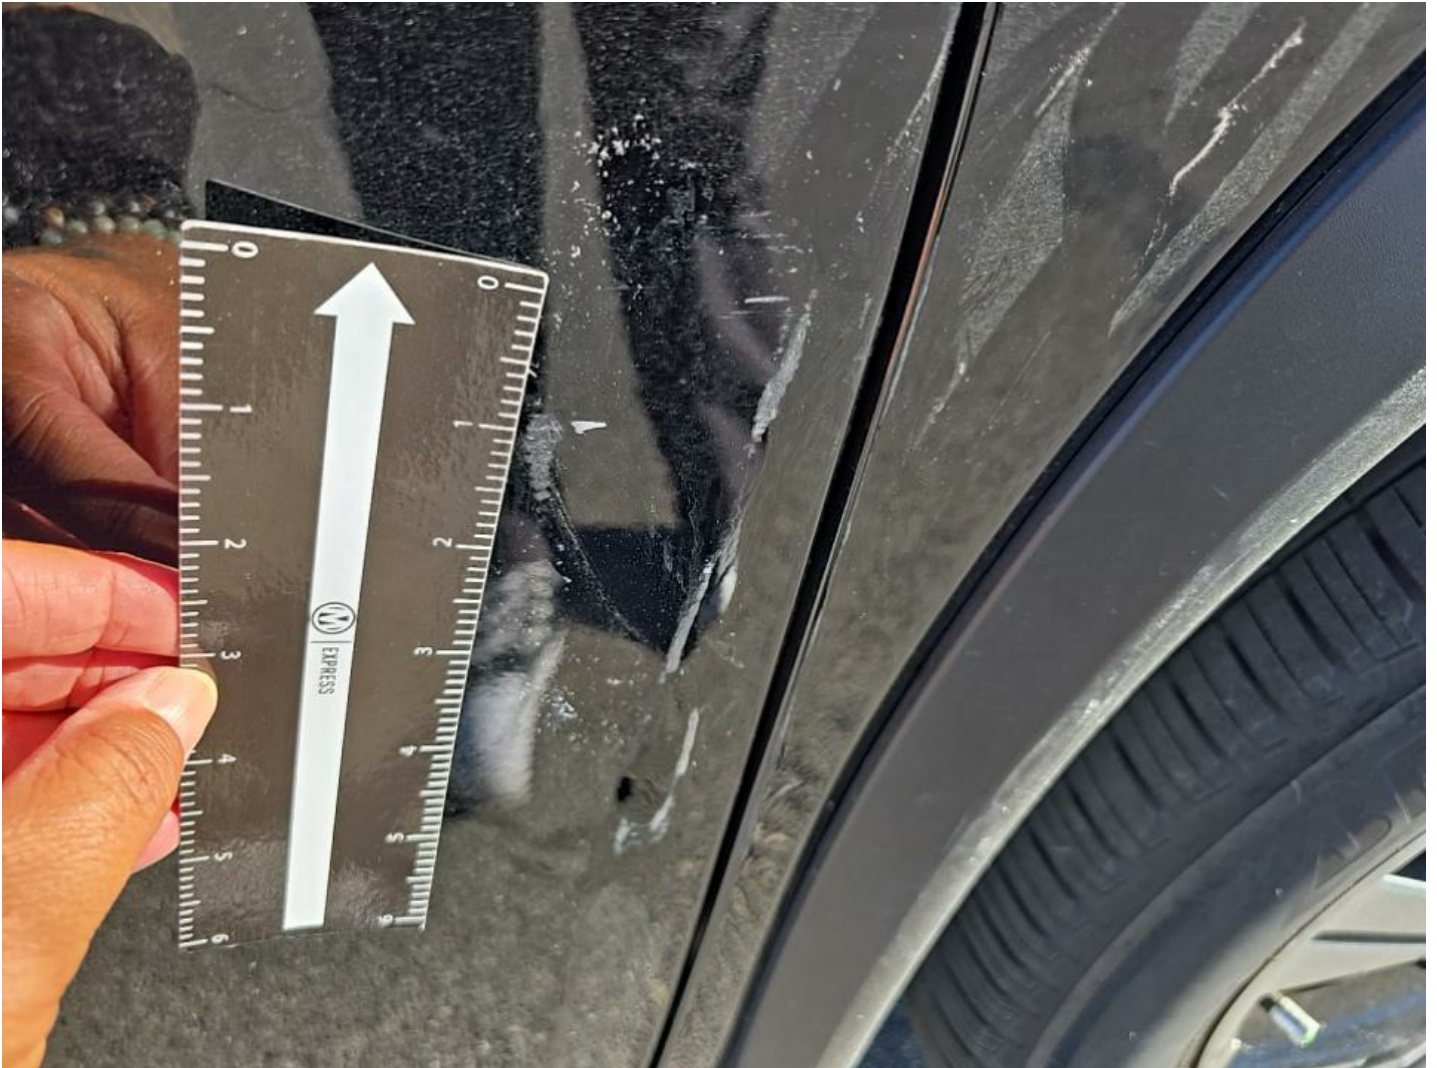
RF Door Dent/Paint Dmg 6" to 7"

| Part Description | Damage Type | Severity | Labor Operation | Labor Total | Paint Total | Part Cost | Total |
|---|---|---|---|---|---|---|---|
| RF Door | Dent/Paint Dmg | 6" to 7" | Body Shop | 160.00 | 128.00 | --- | 288.00 |

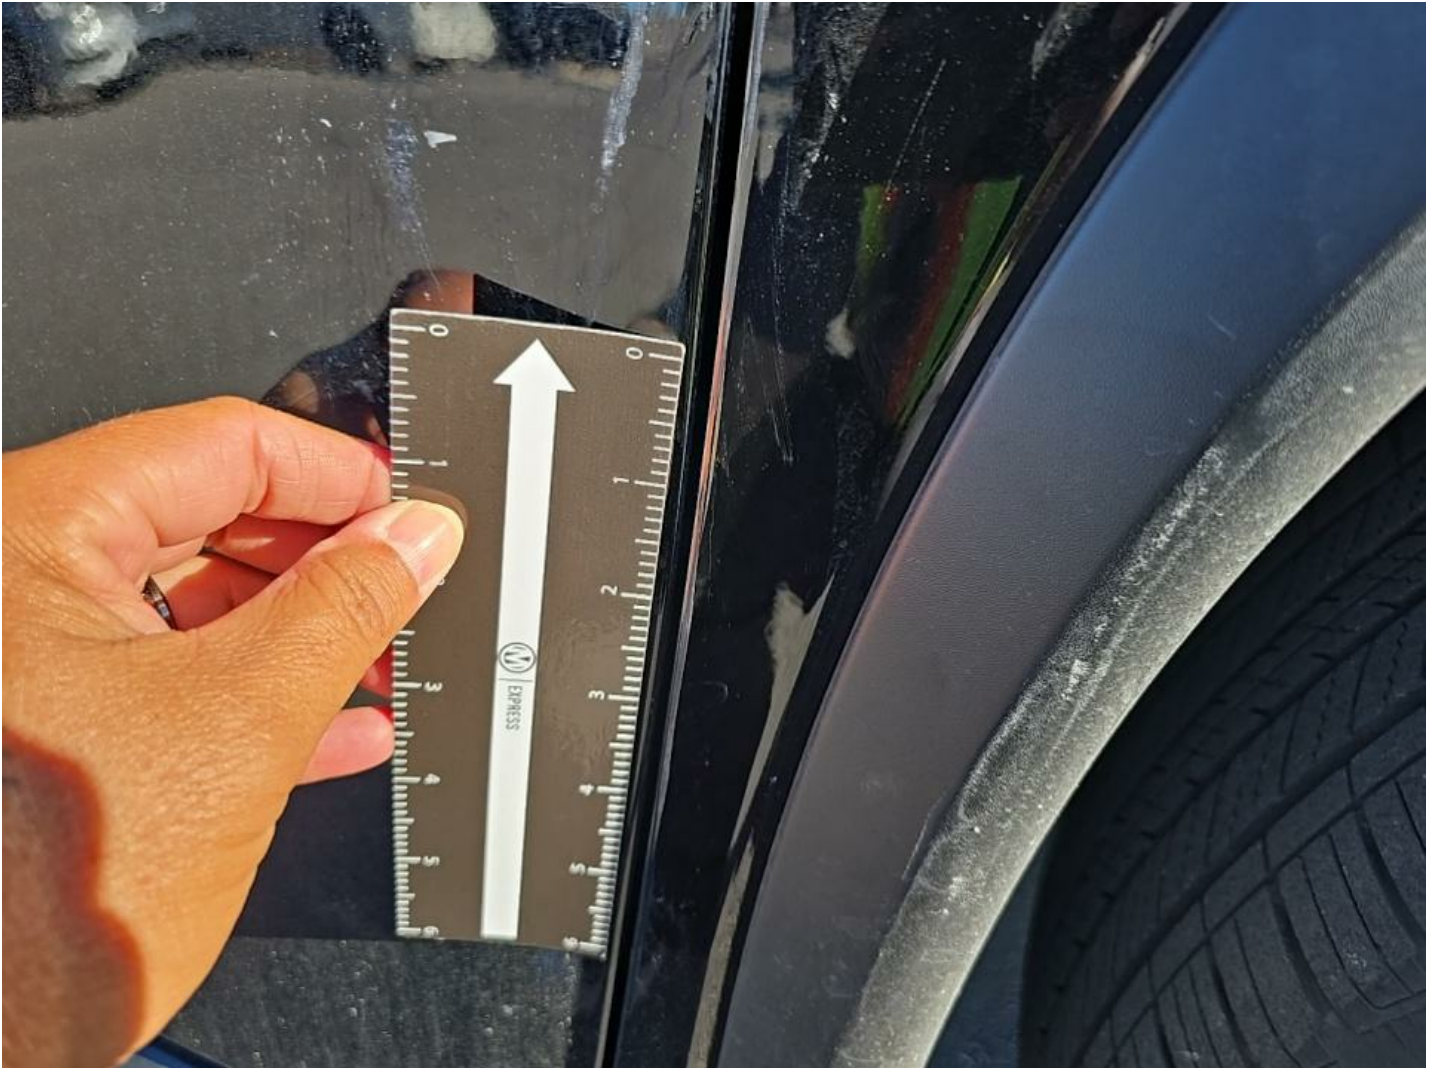
RF Fender Dent/Paint Dmg 1" to 2"

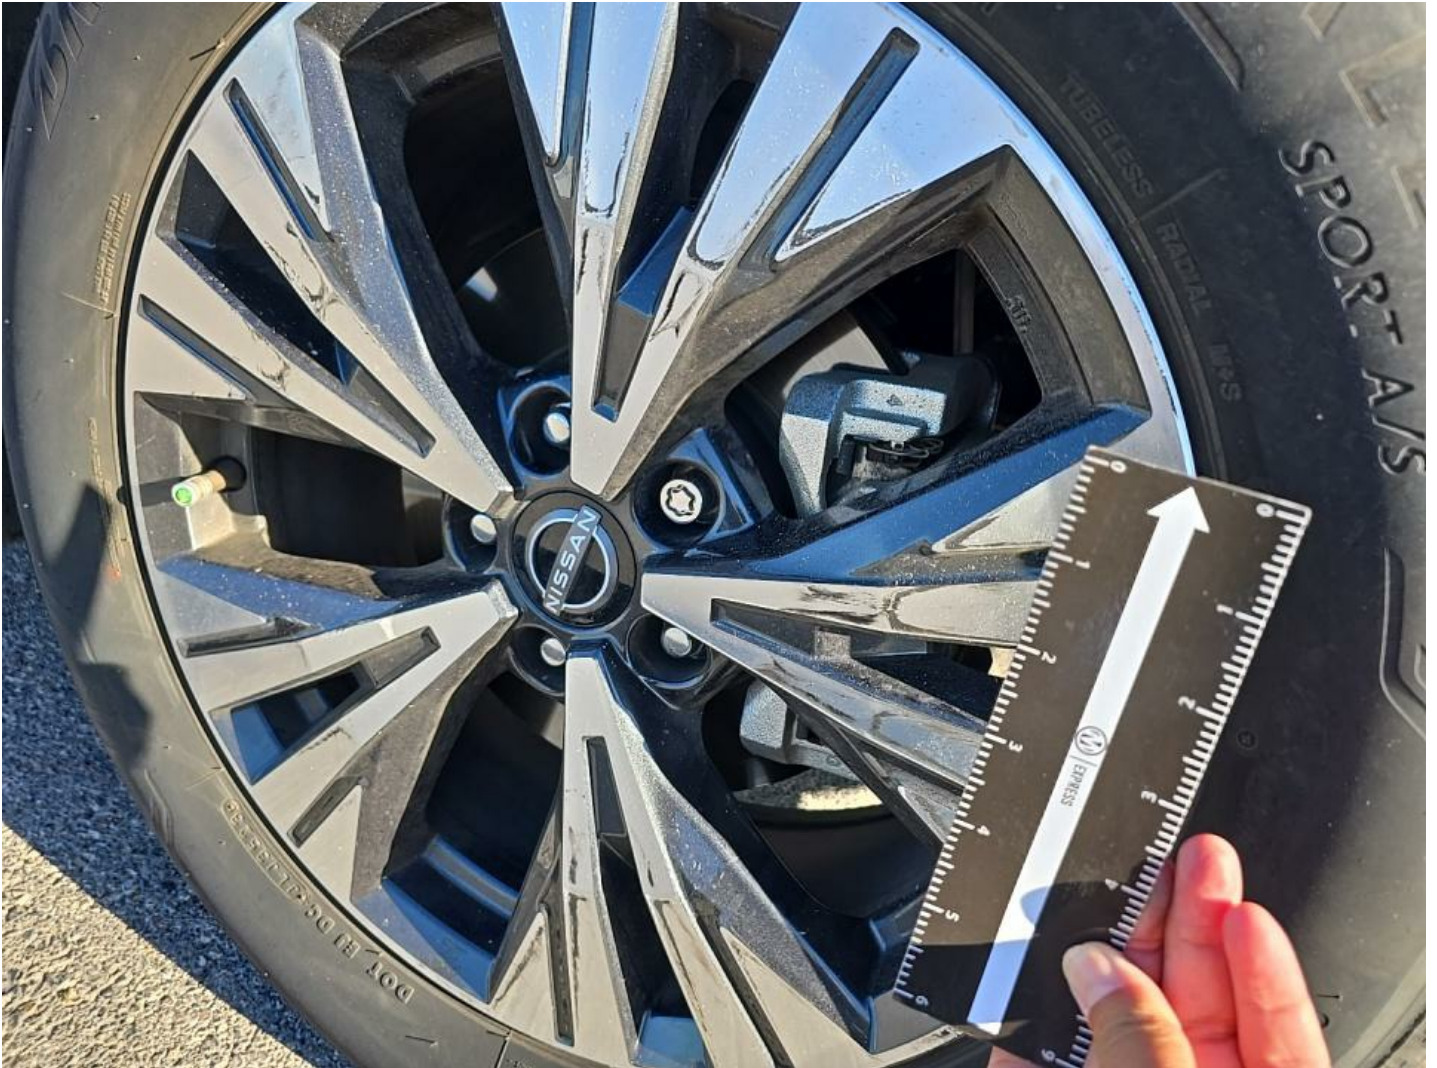
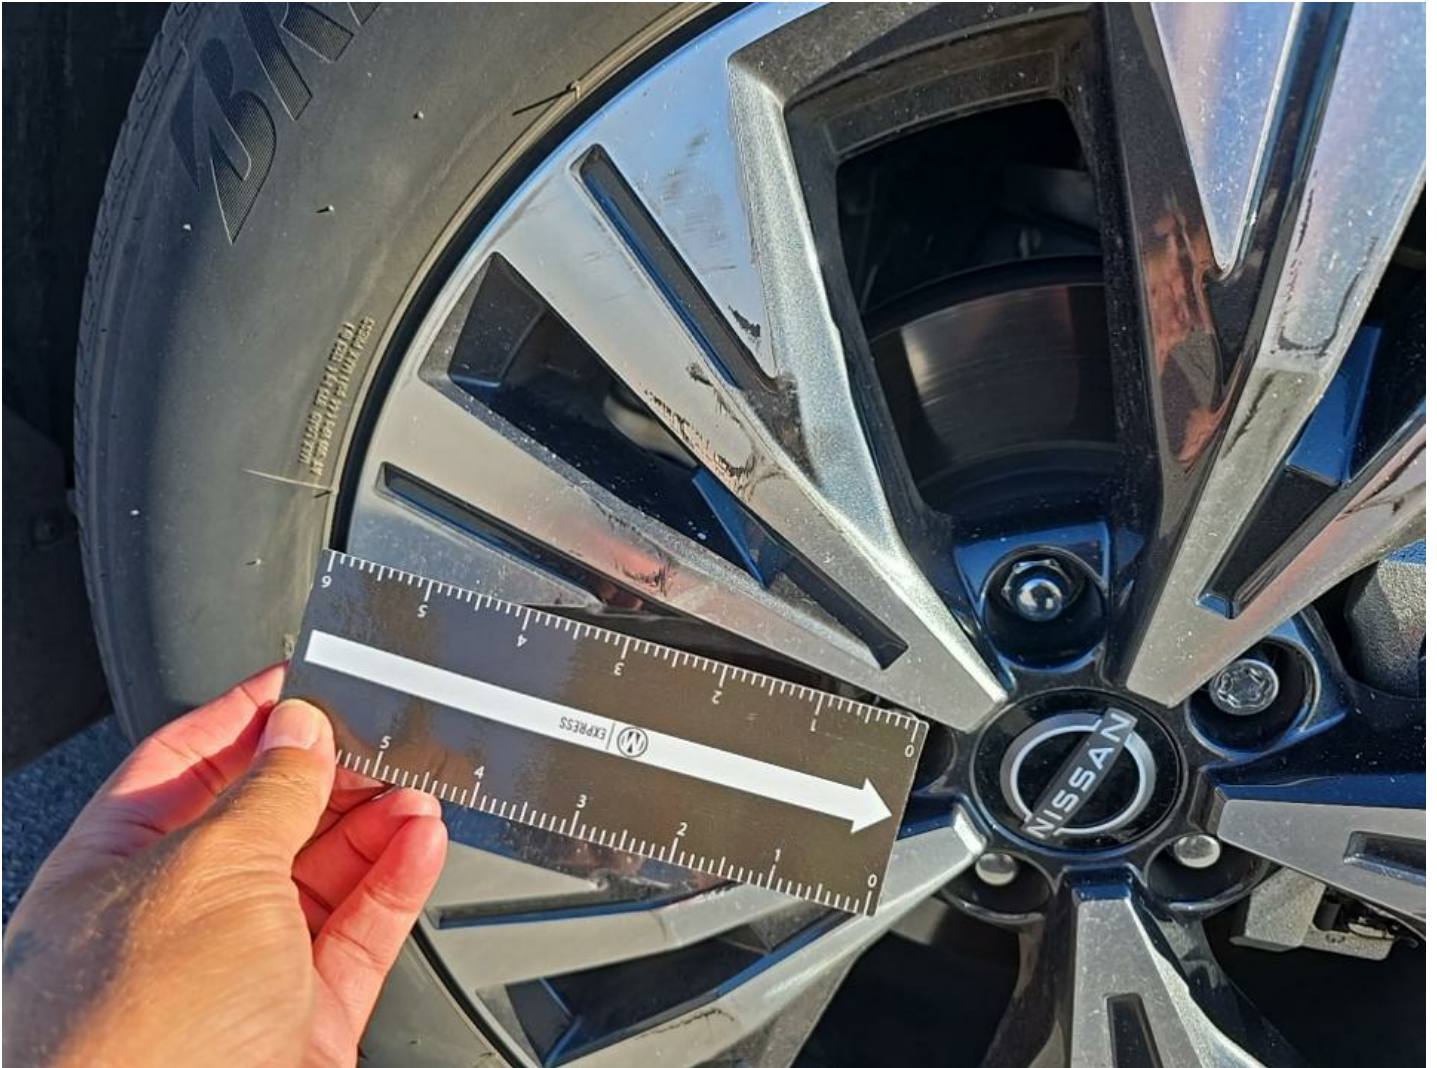
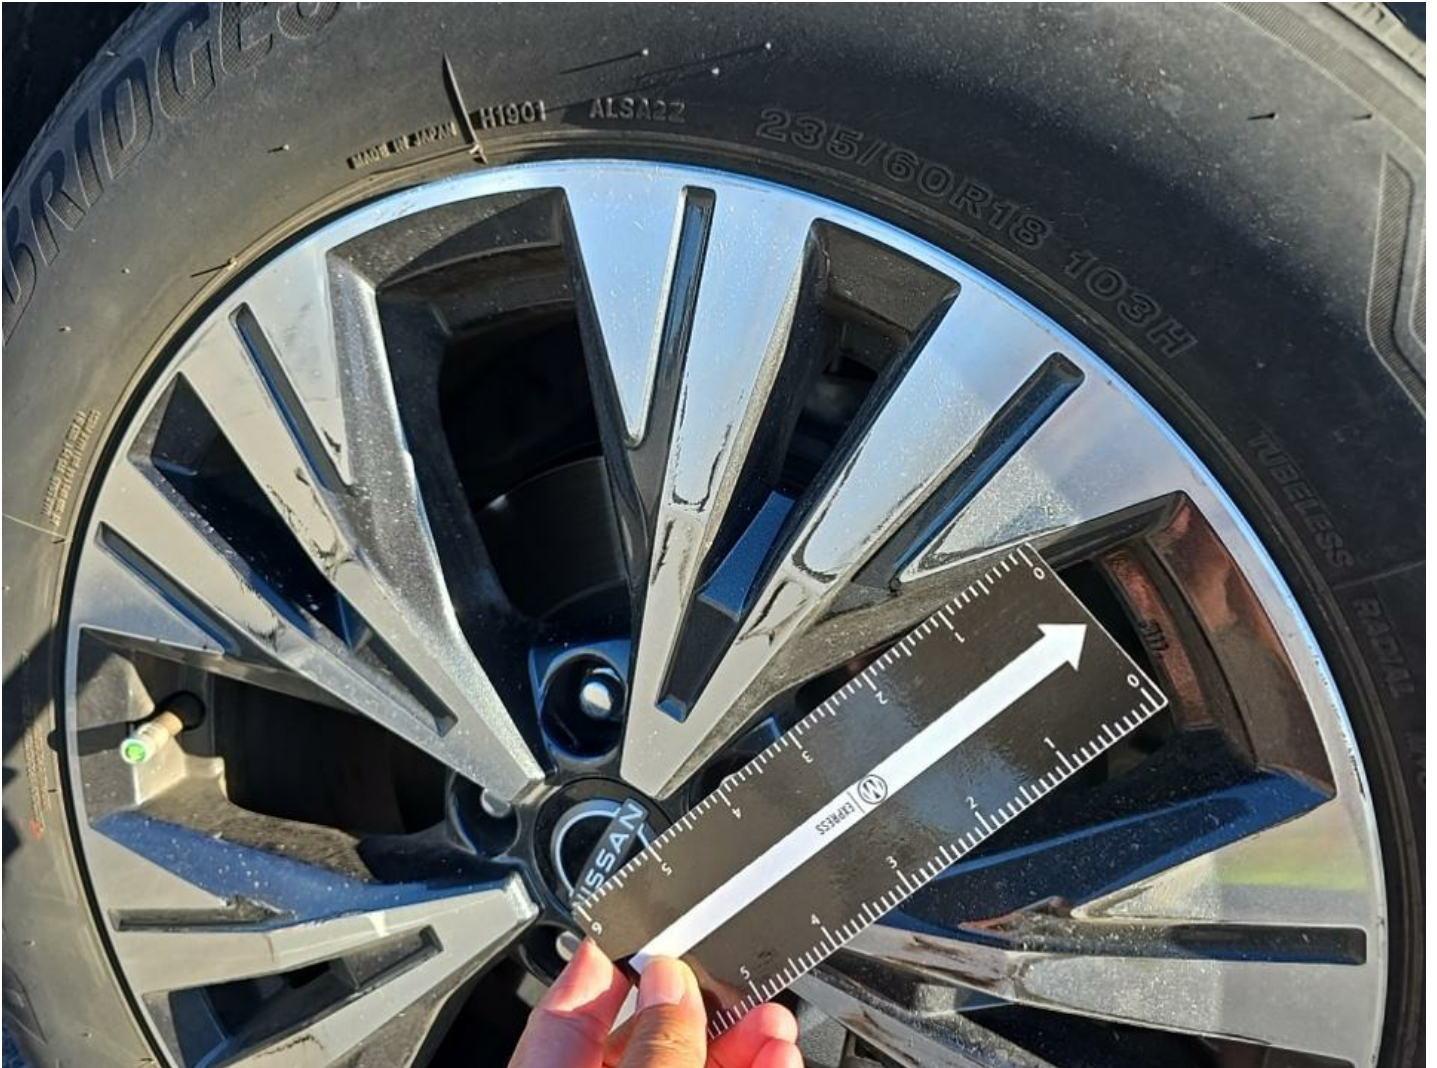
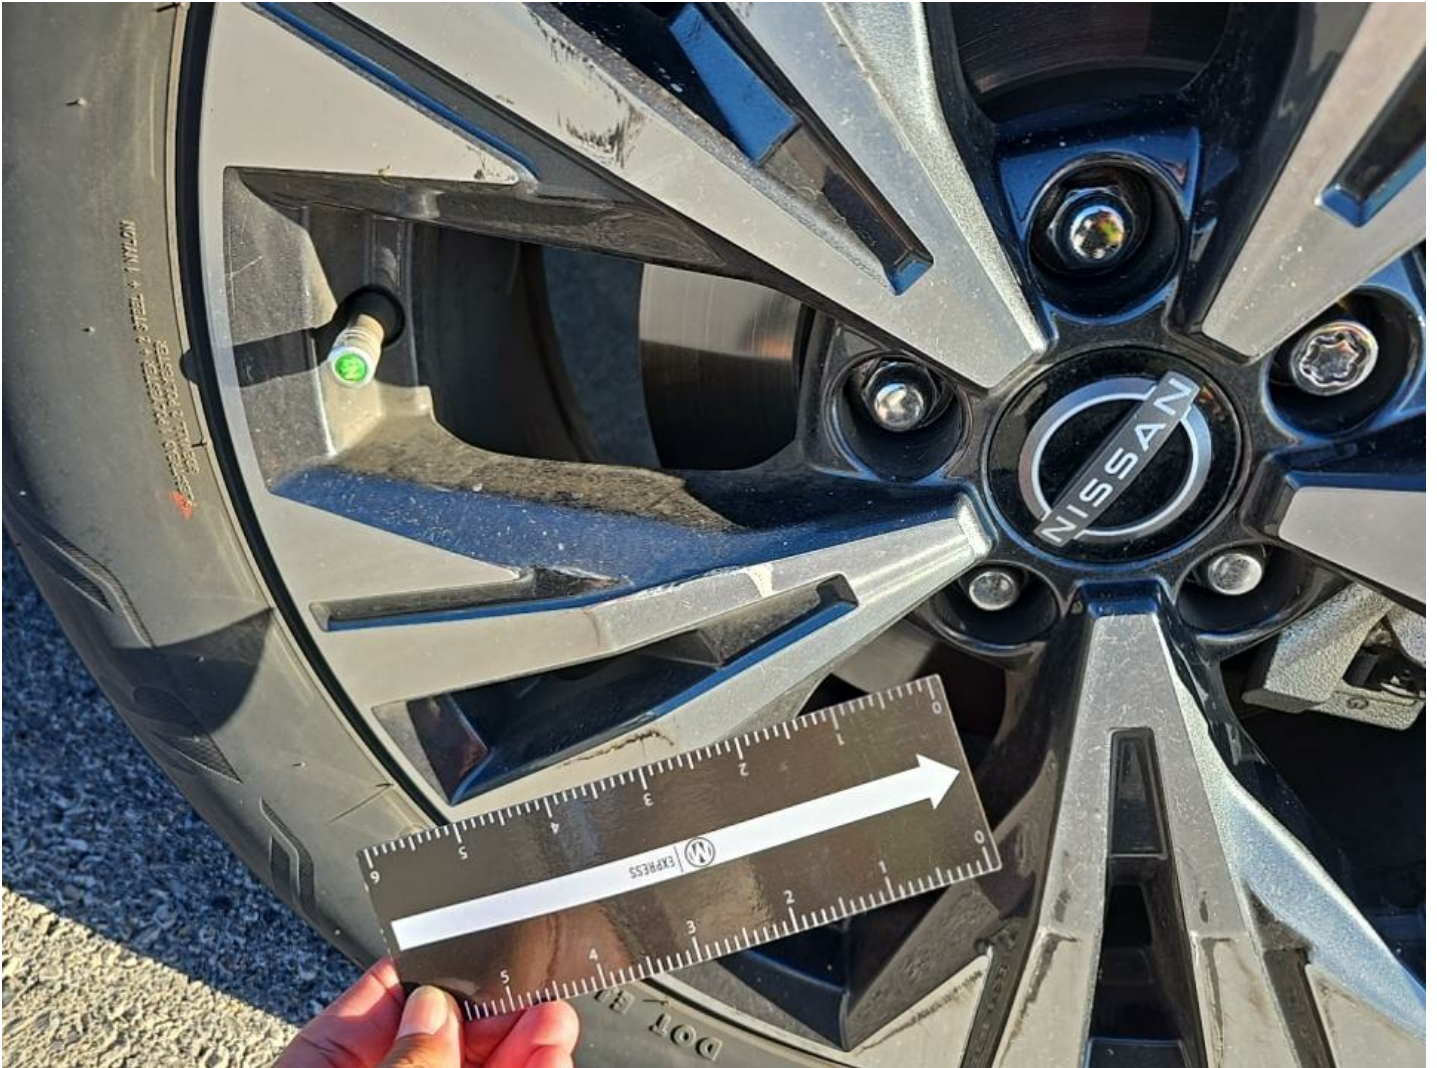
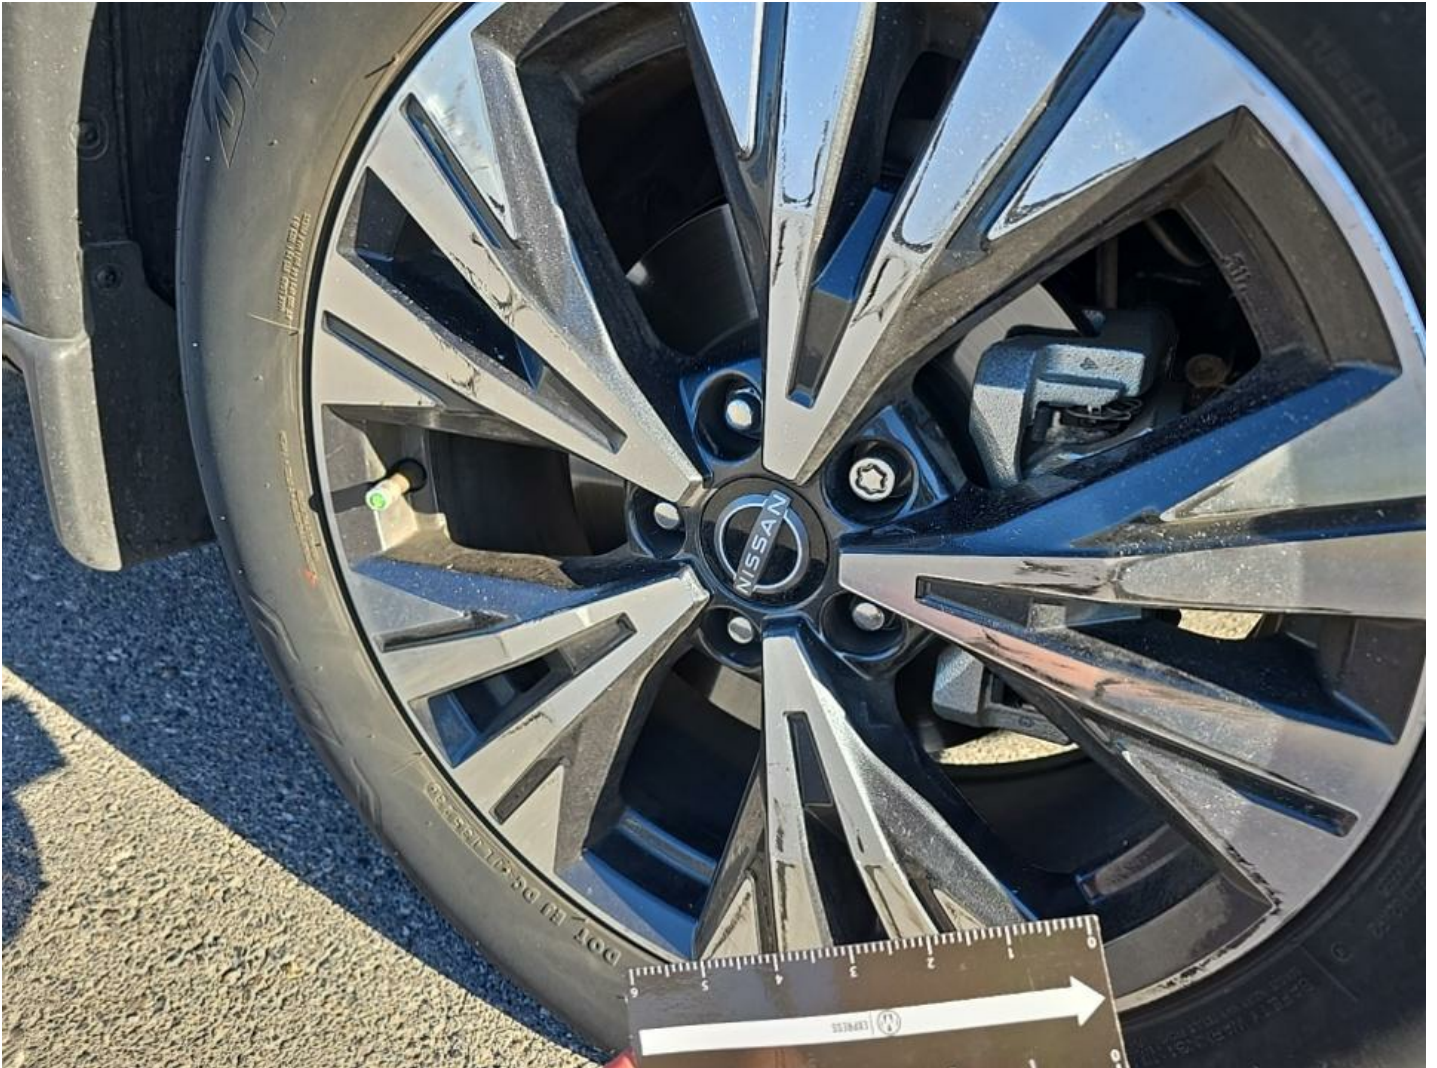
RF Wheel Cover Curb Rash GR 12"

| Part Description | Damage Type | Severity | Labor Operation | Labor Total | Paint Total | Part Cost | Total |
|---|---|---|---|---|---|---|---|
| RF Wheel Cover | Curb Rash | GR 12" | Flat Fee | 0.00 | --- | 0.00 | 25.00 |

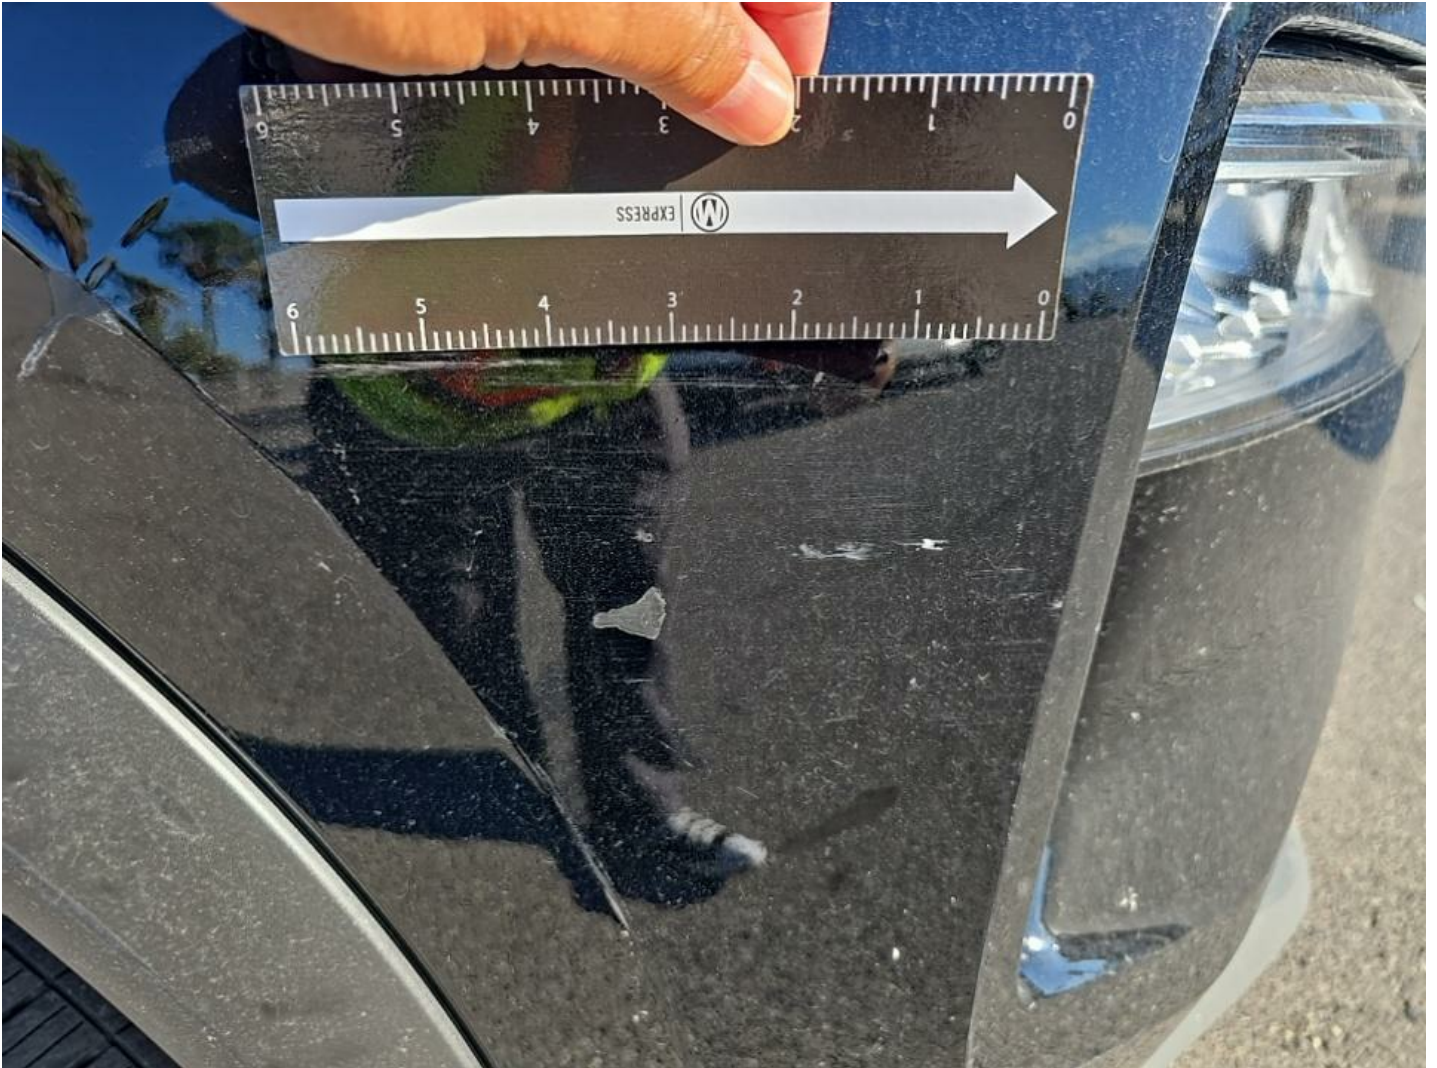
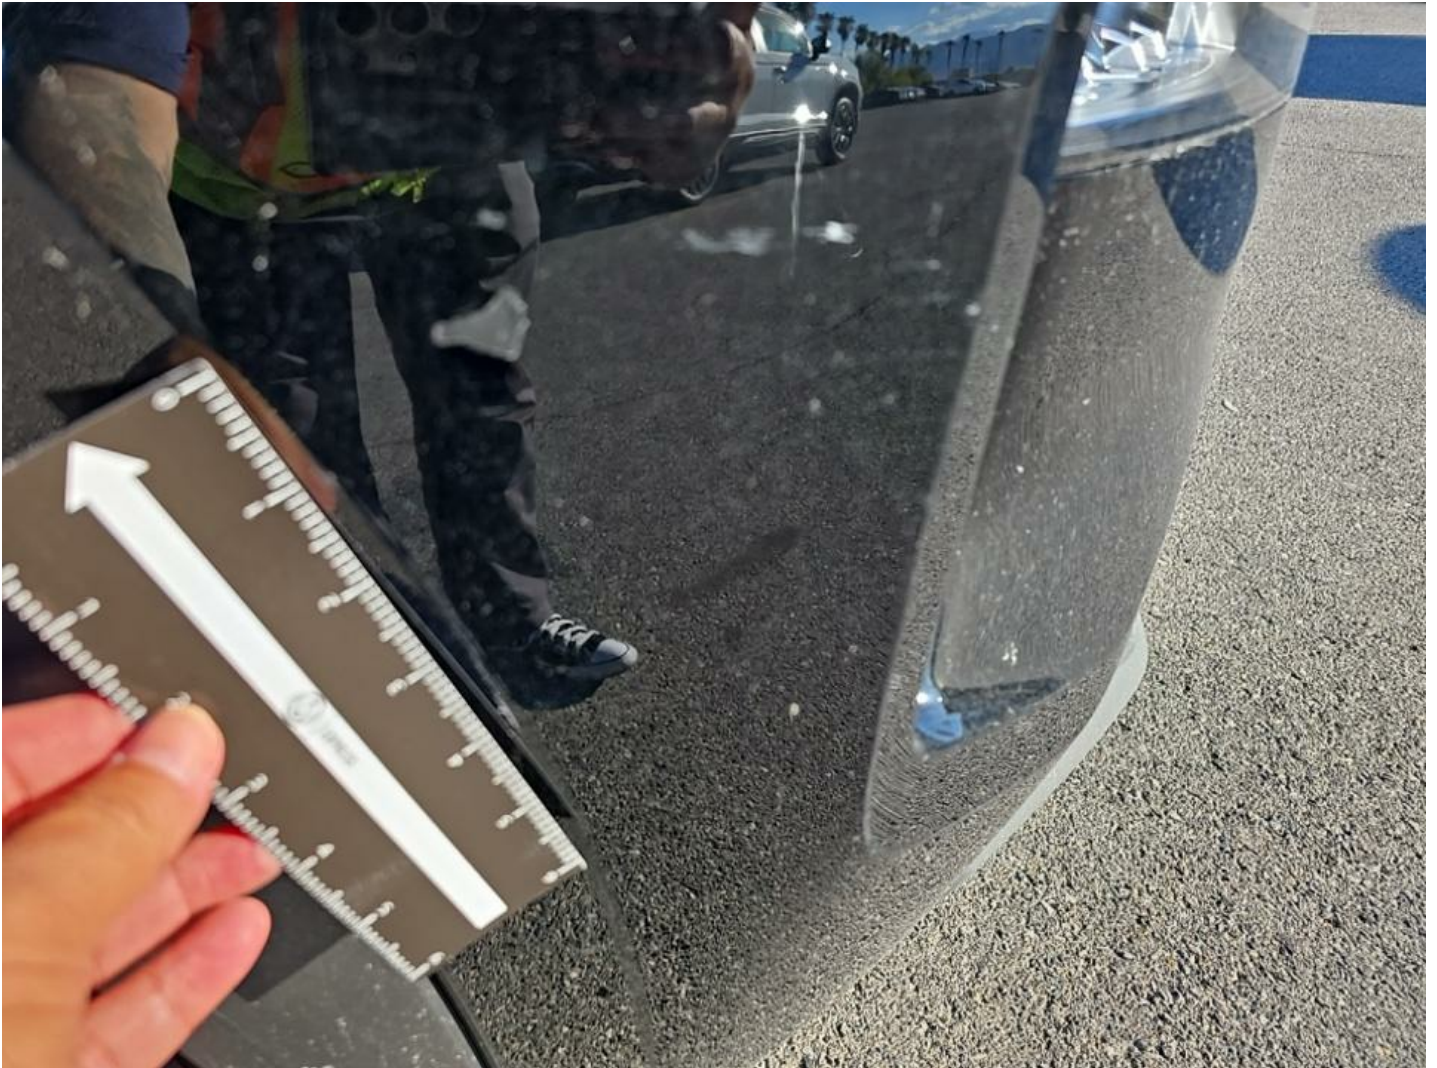
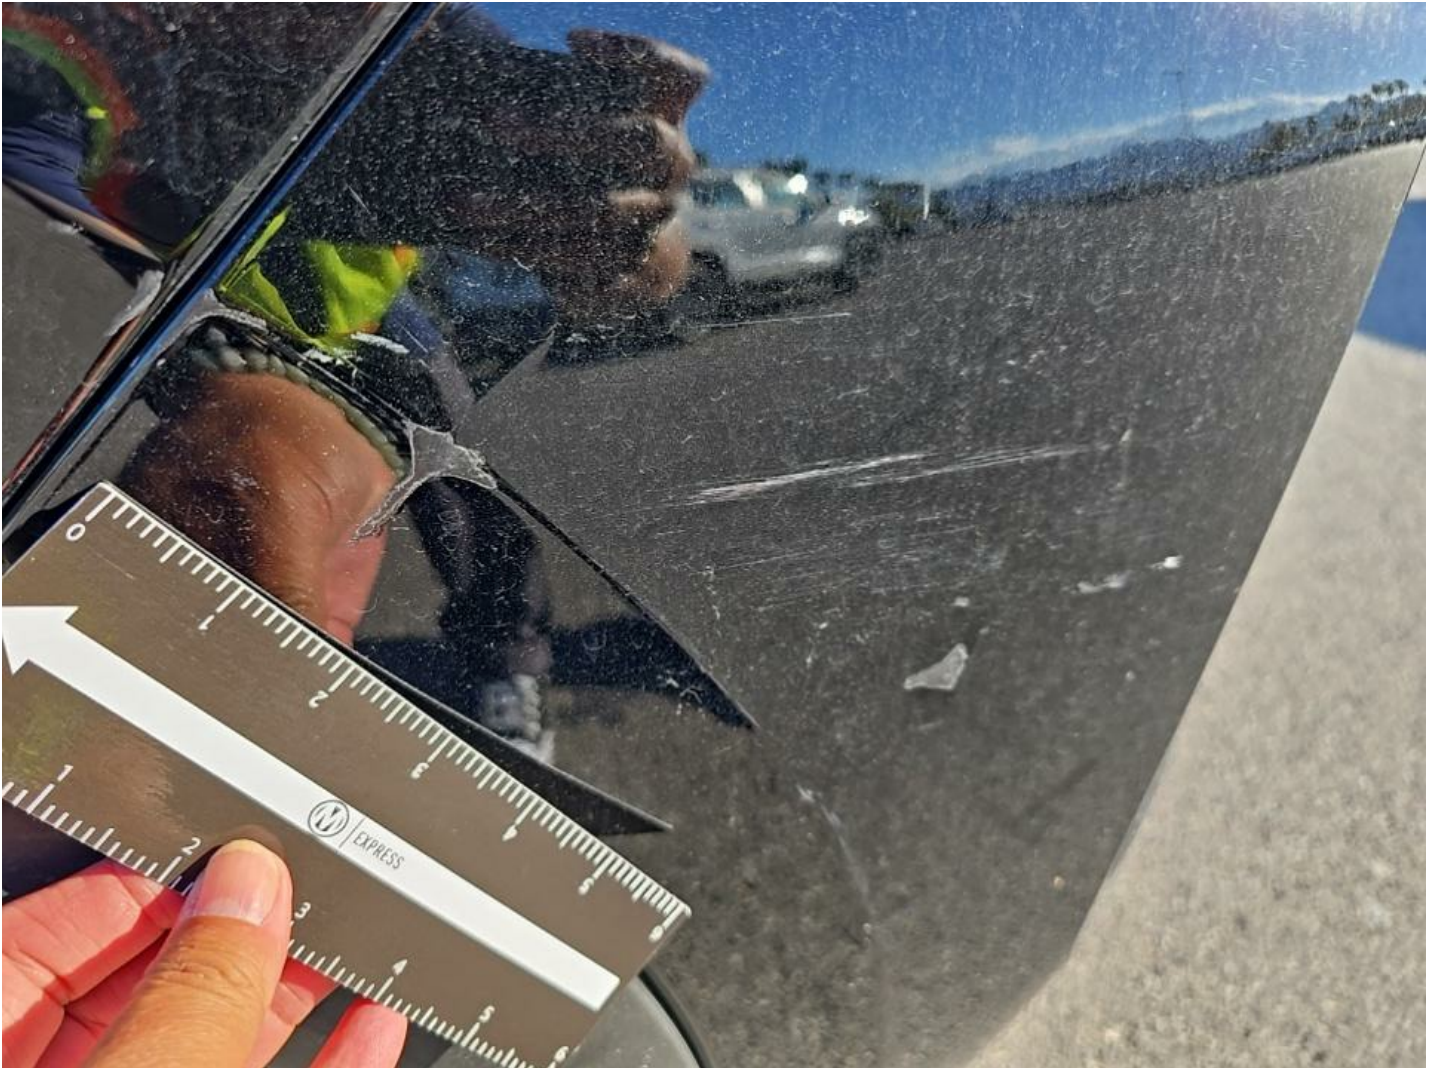
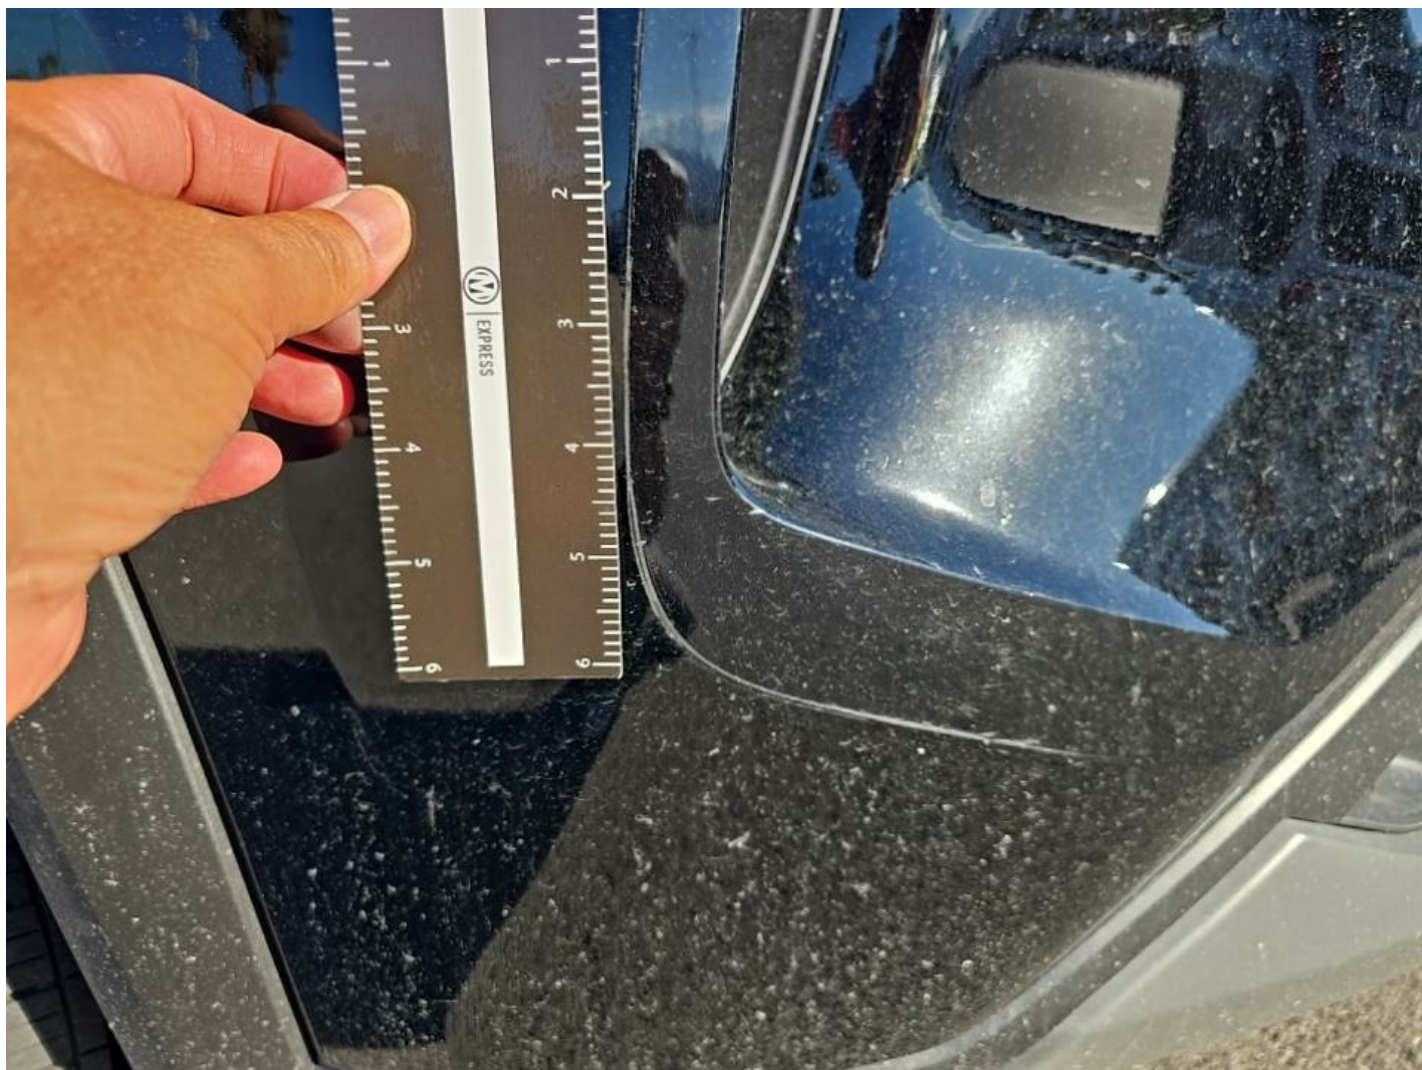
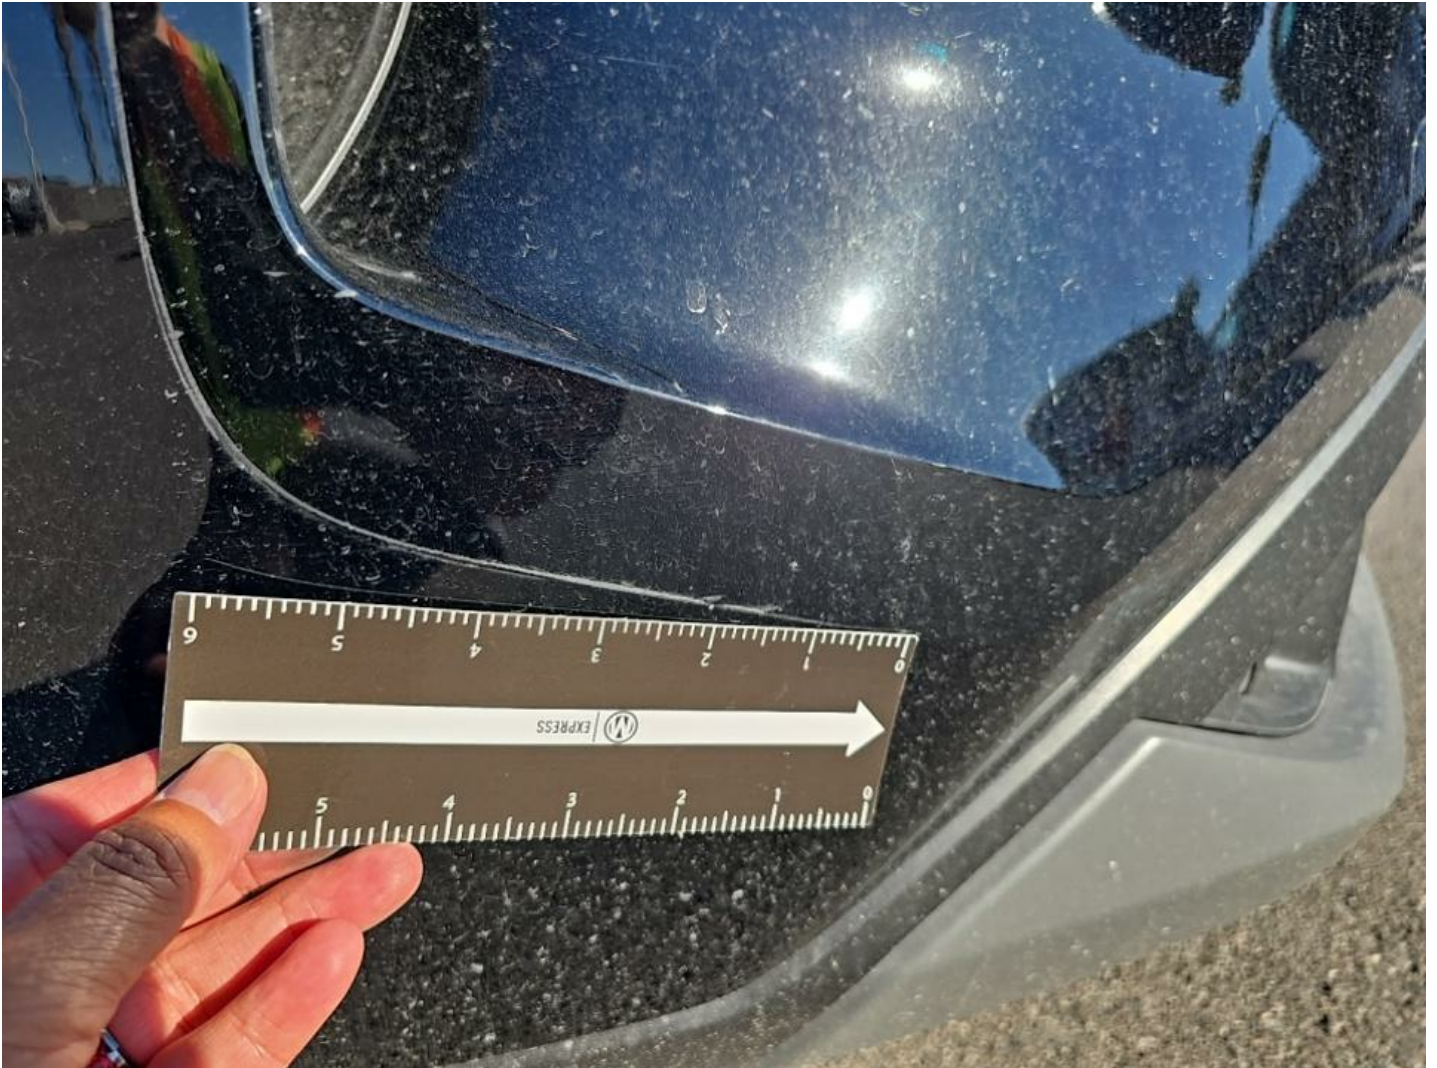
Front Bumper Cover Heavy Mult Scratches 5

| Part Description | Damage Type | Severity | Labor Operation | Labor Total | Paint Total | Part Cost | Total |
|---|---|---|---|---|---|---|---|
| Front Bumper Cover | Heavy Mult Scratches | 5 | Body Shop | 80.00 | 152.00 | --- | 232.00 |
