Manheim by Cox Automotive **Vehicle Report Condition**

VIN:	1N4AZ1BV8SC563247	**Inspection Date:**	2026-08-31
Make, Model, & Year:	Nissan LEAF 2025	**Inspector:**	9128
Trim:	S Hatchback	**Inspection Type:**	nmac
Exterior/Interior Color:	QAK - Glacier White / G - Black	**Odometer:**	10589 Miles
Roof Type:	Hard Top

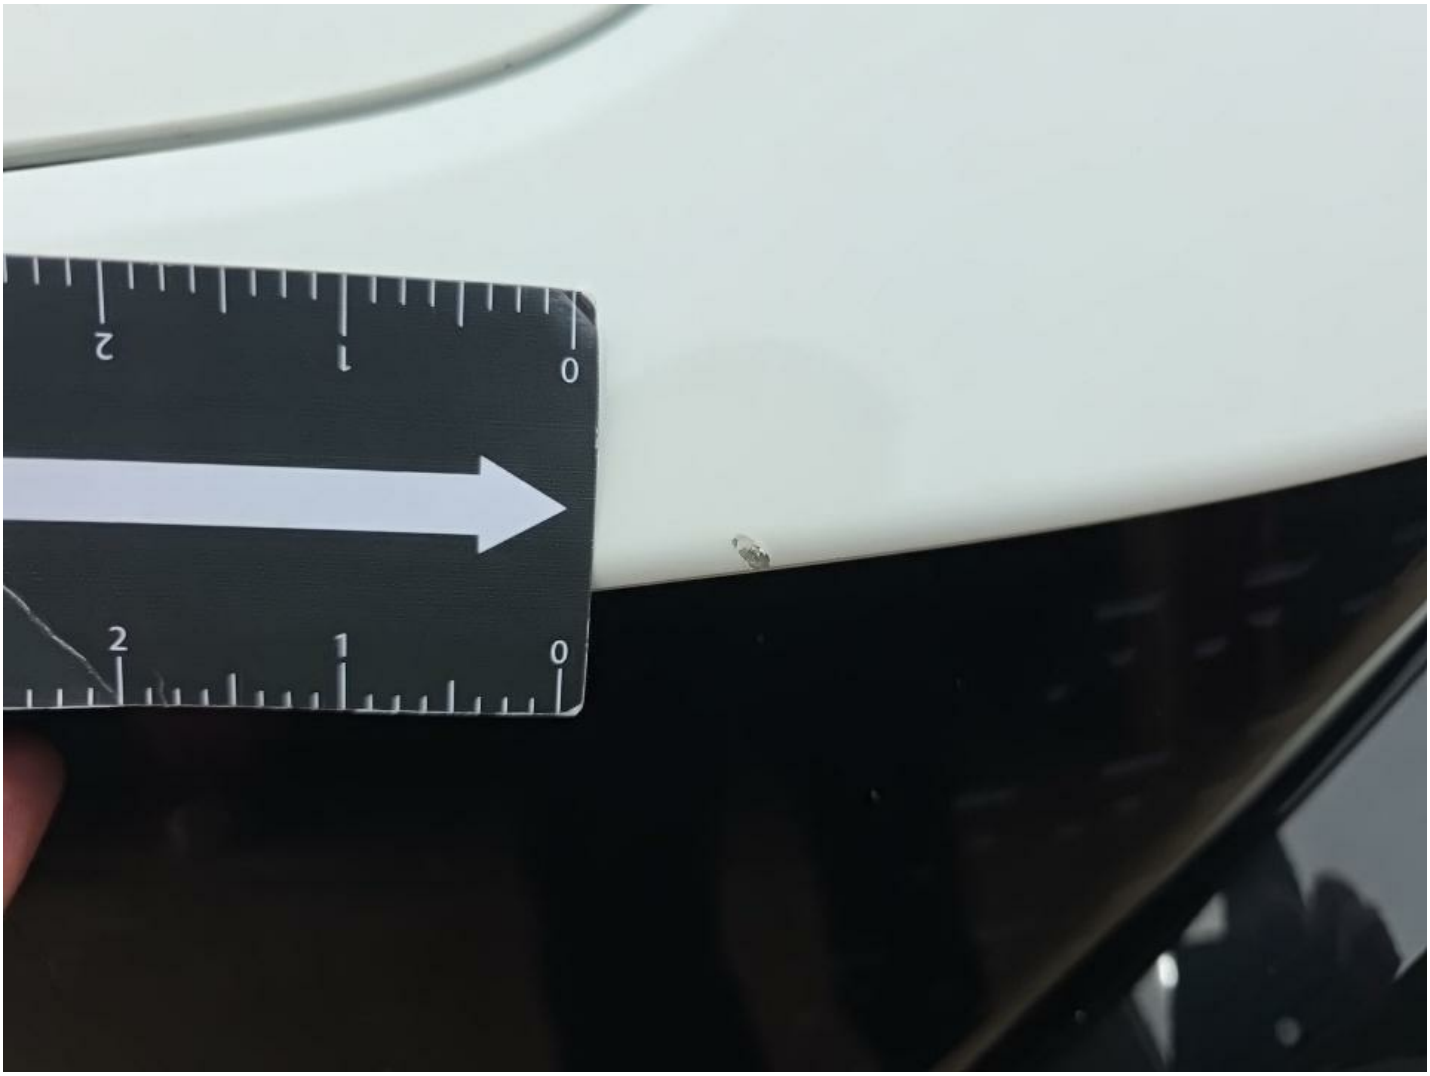
Front Bumper Chipped 3

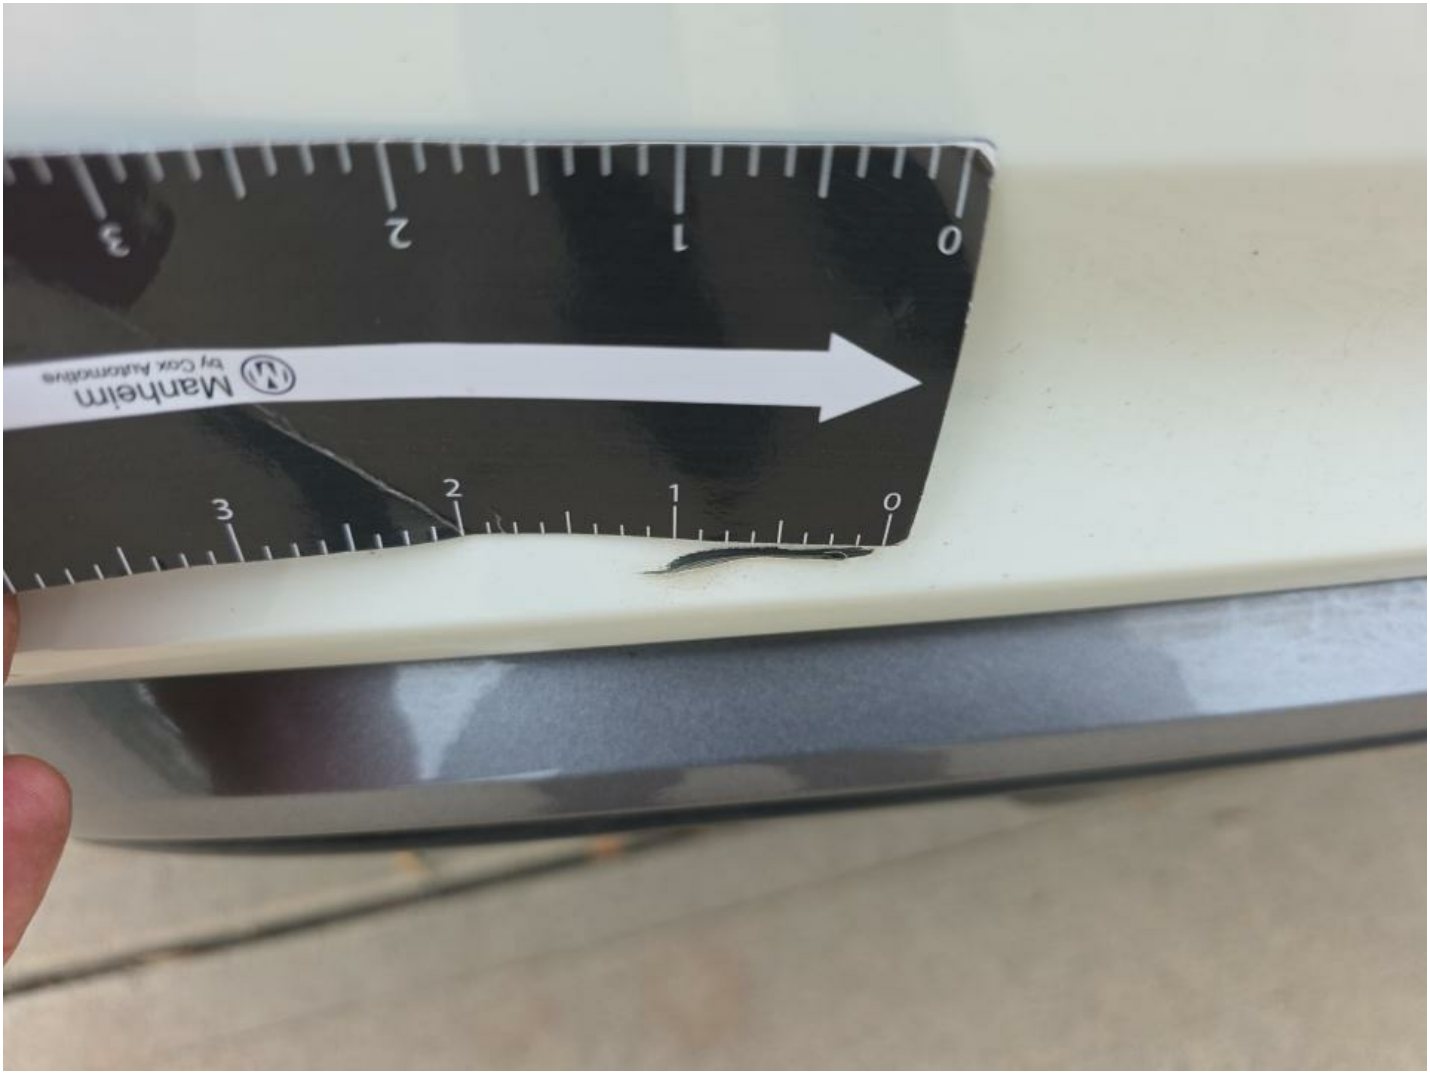
Rear Bumper Gouged 1" to 2"
