Manheim by Cox Automotive **Vehicle Report Condition**

VIN:	1N4BL4DV0RN341160	**Inspection Date:**	2026-09-16
Make, Model, & Year:	Nissan Altima 2024	**Inspector:**	10563
Trim:	2.5 SV Sedan	**Inspection Type:**	nmac
Exterior/Interior Color:	K23 - Brilliant Silver Metallic / G - Charcoal	**Odometer:**	12837 Miles
Roof Type:	Sun/Moonroof

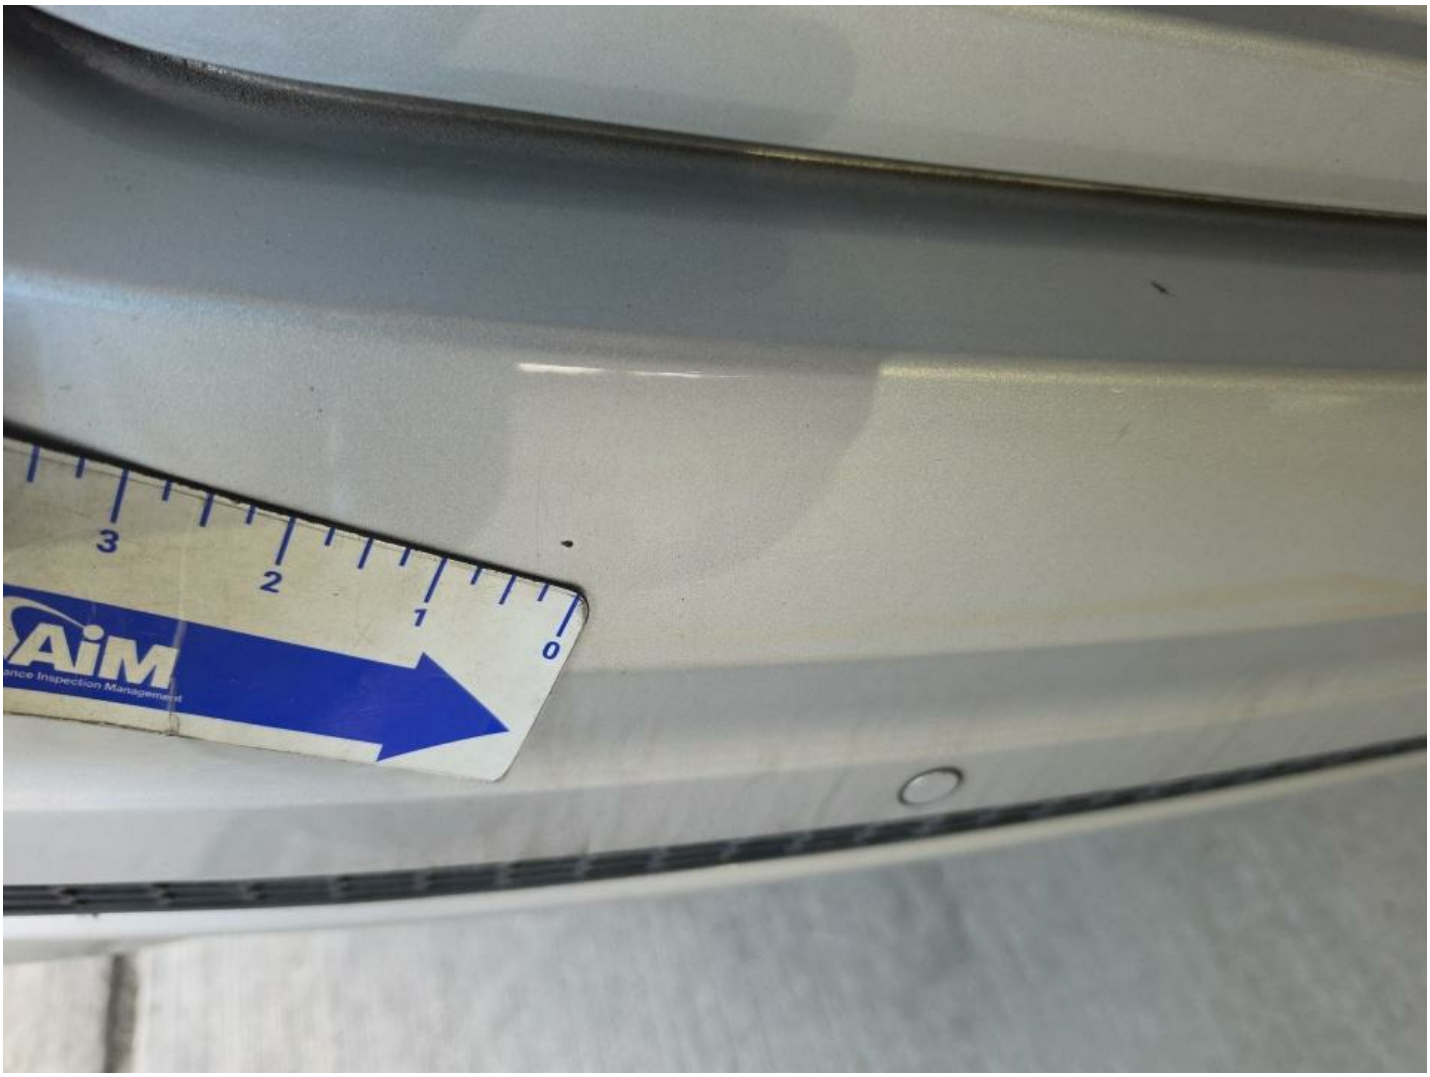
F Bumper Left Molding Heavy Mult Scratches Replacement Required

Part Description	Damage Type	Severity	Labor Operation	Labor Total	Paint Total	Part Cost	Total
F Bumper Left Molding	Heavy Mult Scratches	Replacement Required	Replace	0.00	----------	27.89	27.89
Rear Bumper	De-Identify		Flat Fee	0.00	----------	0.00	20.00
TOTAL:							**$ 47.89**
