Manheim
by Cox Automotive **Vehicle Report Condition**

VIN:	5N1BT3ABXPC885457	**Inspection Date:**	2026-09-15
Make, Model, & Year:	Nissan Rogue 2023	**Inspector:**	5324
Trim:	AWD S	**Inspection Type:**	nmac
Exterior/Interior Color:	NBL - Scarlet Ember Tintcoat / G - Charcoal	**Odometer:**	9704 Miles
Roof Type:	Hard Top

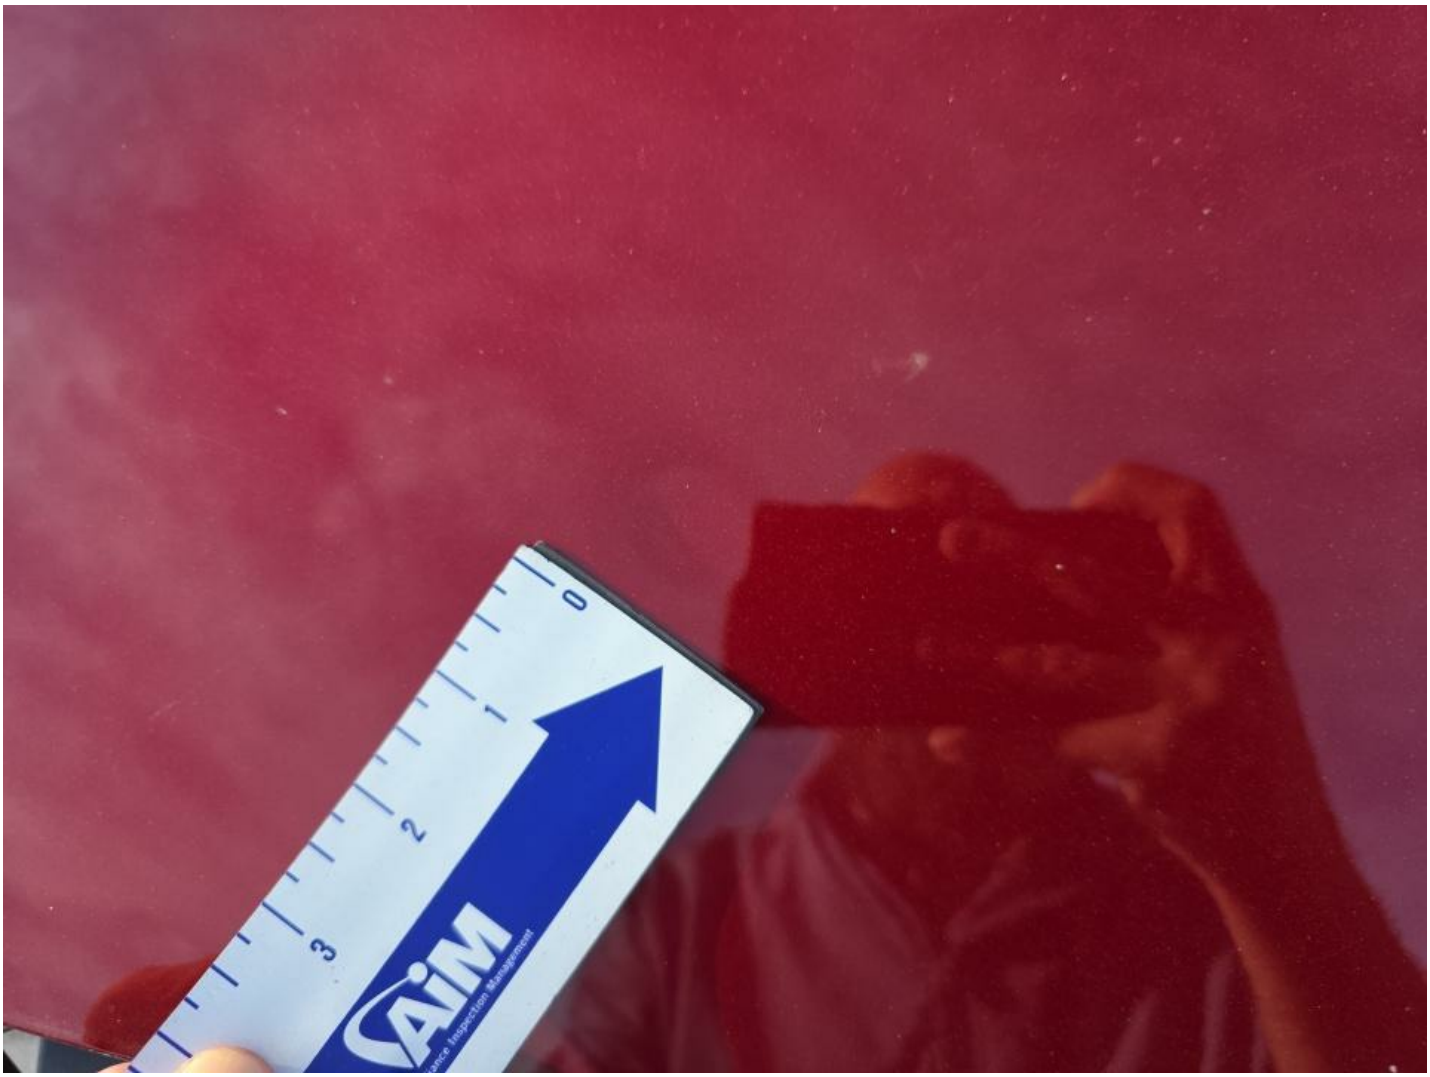
LF Door Dent/Paint Dmg 2" to 3"
