Manheim
by Cox Automotive **Vehicle Report Condition**

VIN:	JN8BT3BB7PW487161	**Inspection Date:**	2026-09-09
Make, Model, & Year:	Nissan Rogue 2023	**Inspector:**	4796
Trim:	AWD SV	**Inspection Type:**	nmac
Exterior/Interior Color:	K23 - Brilliant Silver Metallic / G - Charcoal	**Odometer:**	33681 Miles
Roof Type:	Hard Top

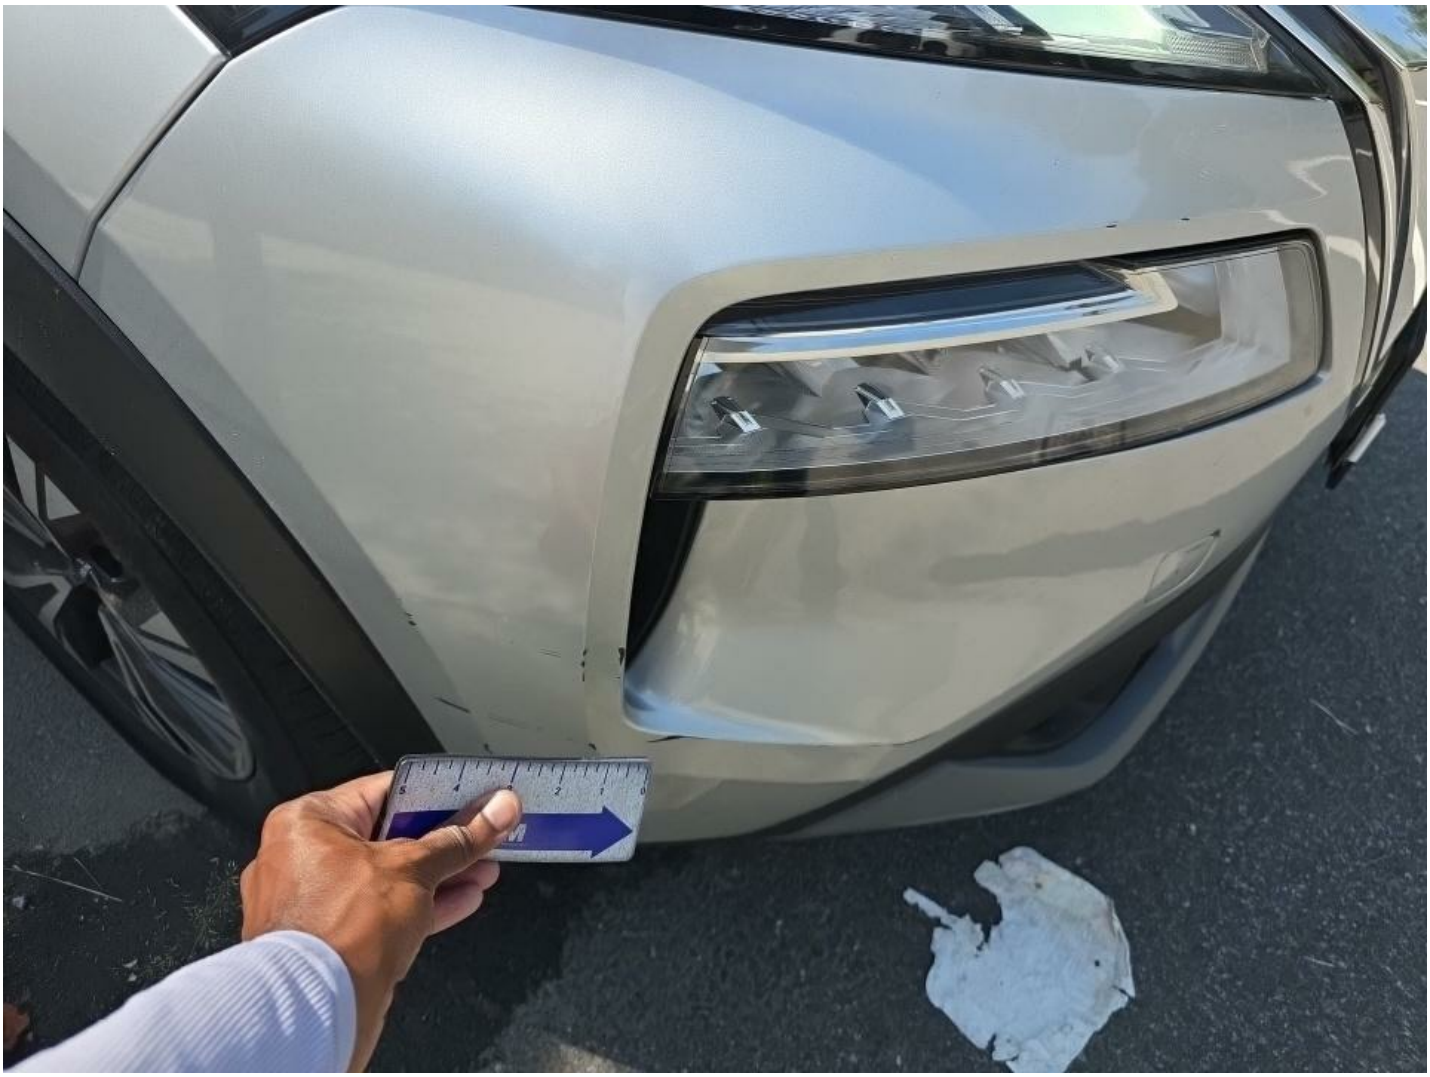
Part Description	Damage Type	Severity	Labor Operation	Labor Total	Paint Total	Part Cost	Total
Front Bumper	Heavy Mult Scratches	4	Body Shop	80.00	152.00	----------	232.00
TOTAL:							**$ 232.00**

Front Bumper Heavy Mult Scratches 4
