| <b>Make, Model, &amp; Year:</b> | Nissan Altima 2024 |
| <b>Trim:</b> | 2.5 SV AWD Sedan |

Vehicle Report Condition

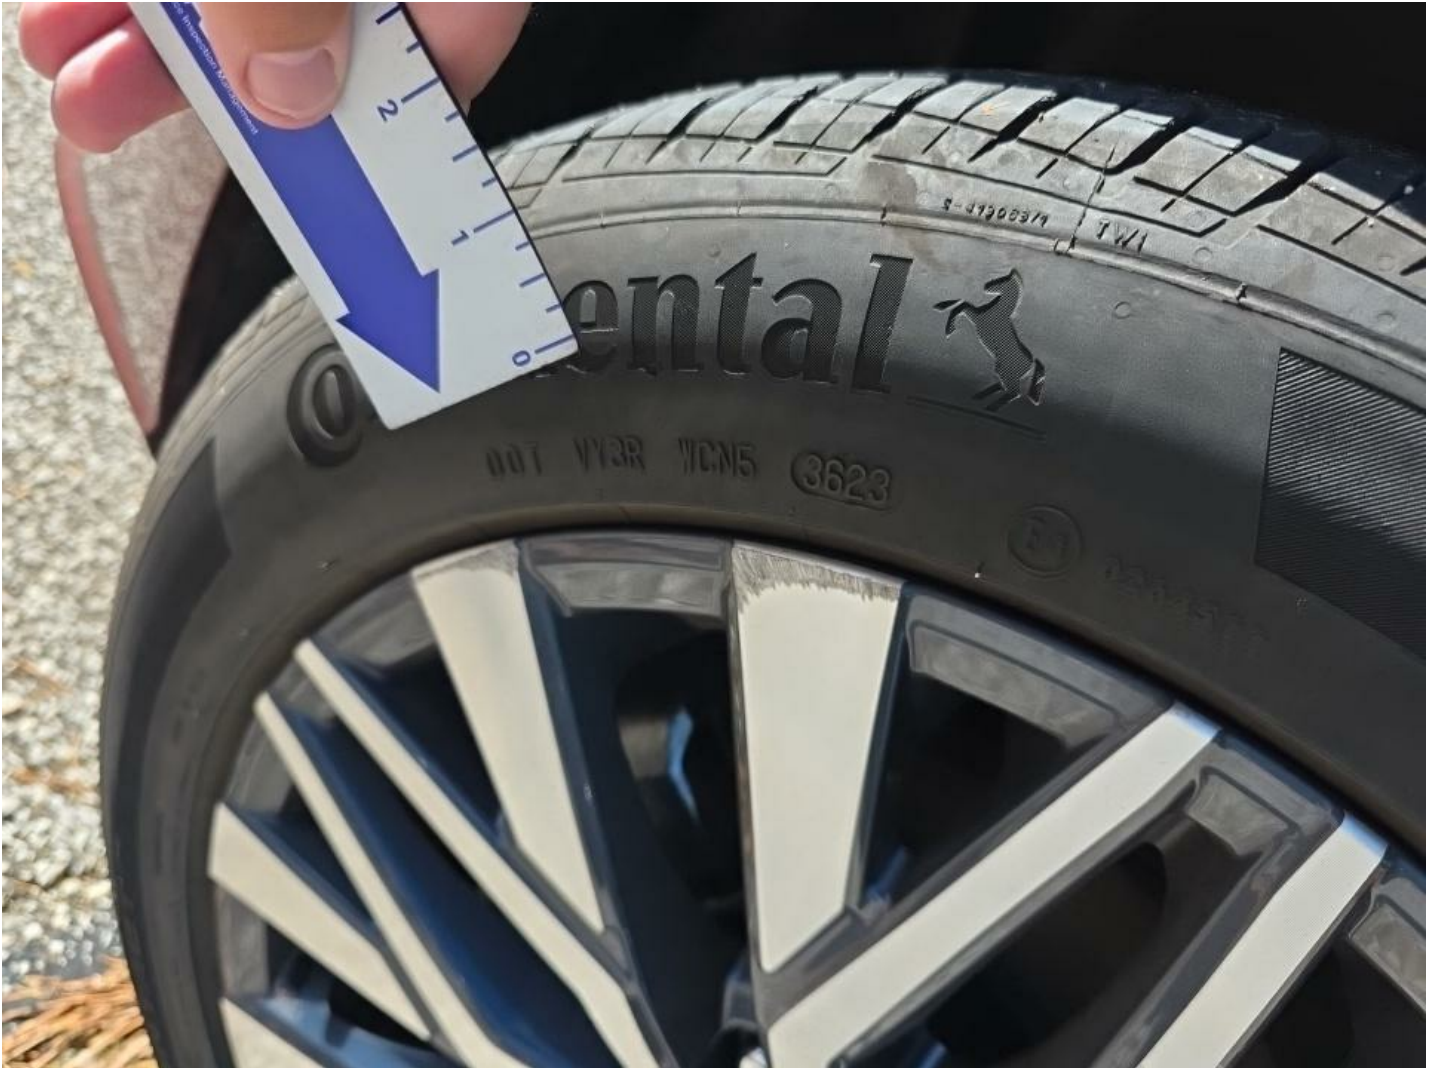
LF Wheel Curb Rash 2" to 3"

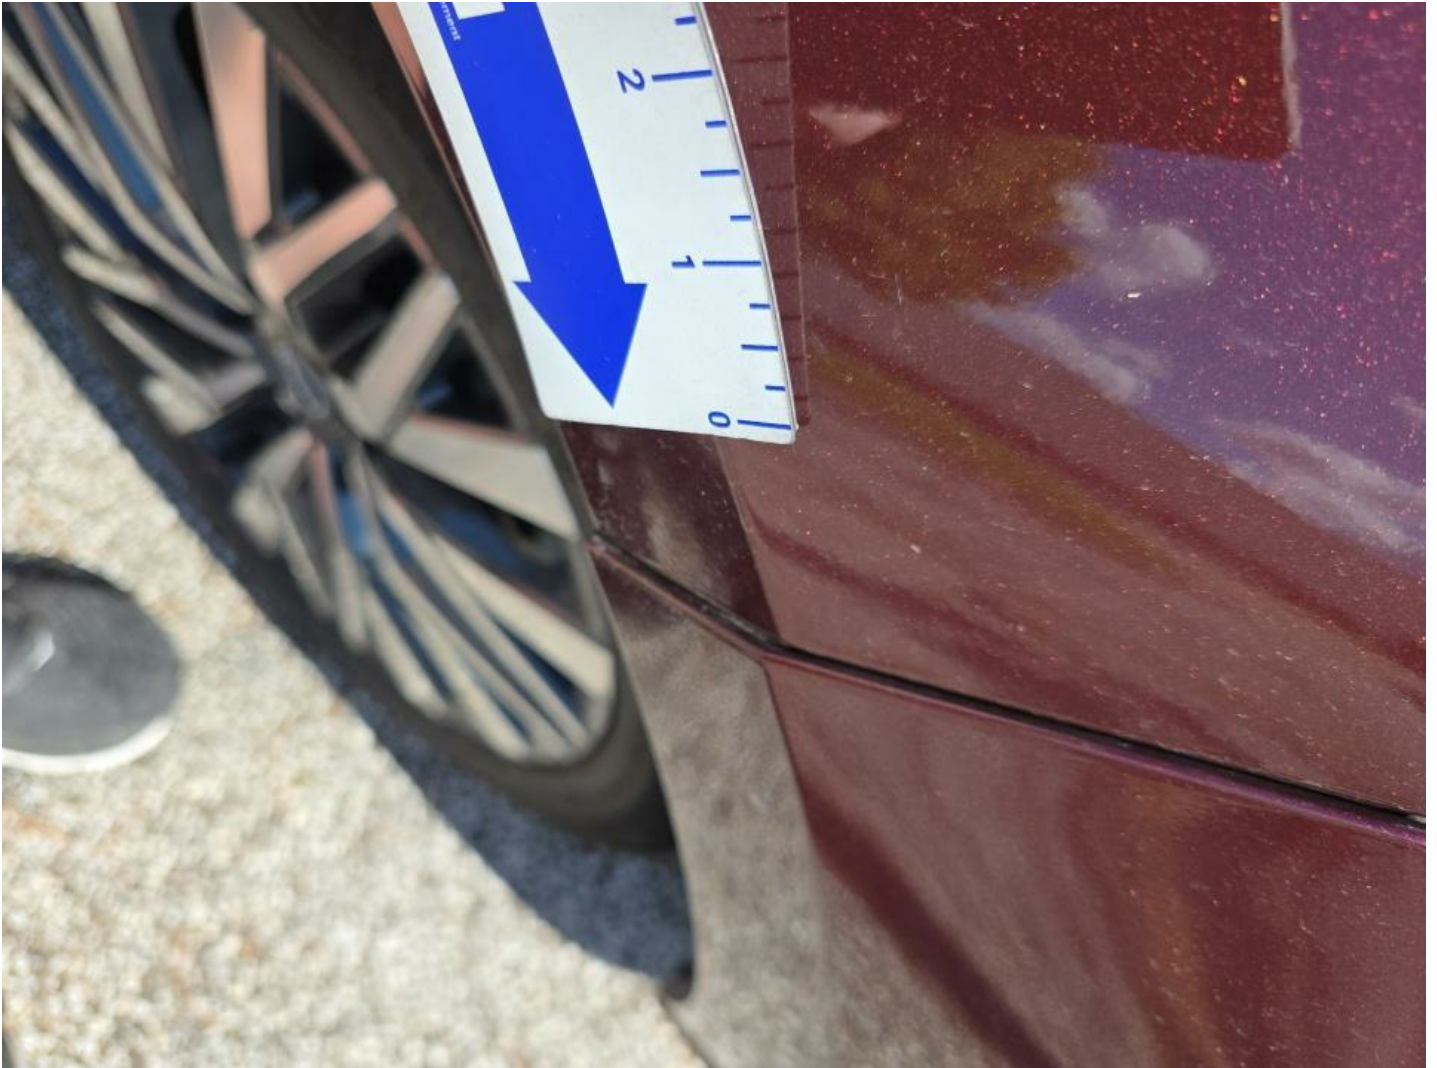
Front Bumper Misaligned Repair Required

| Part Description | Damage Type | Severity | Labor Operation | Labor Total | Paint Total | Part Cost | Total |
|---|---|---|---|---|---|---|---|
| Front Bumper | Misaligned | | Flat Fee | 0.00 | --- | 0.00 | 80.00 |
